# TSB 21-007-06

## RFE Transmission Filters - Delayed Engagement And Related Transmission DTC'S

**Date:** April 07, 2006

**Models:** 2005 - 2006 (DR) Ram Truck

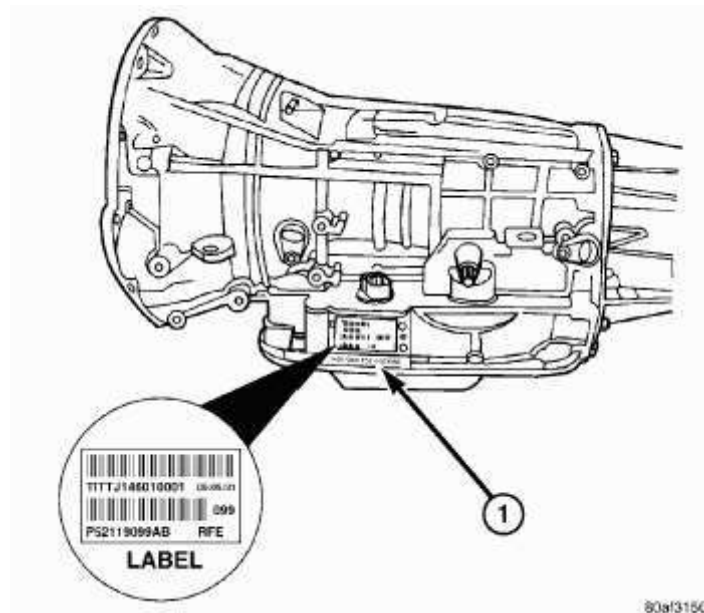
FIGURE 1 - TRANS IDENTIFICATION NUMBER

3. Inspect for the transmission build date (Julian date) (Fig. 1). The transmission build date can be determined by inspection of the 20 digit transmission identification number (DDDYxxxxxPpartnumber). The transmission identification number is stamped on the left side (driver side) of the transmission oil pan flange. The first four (4) digits of the transmission identification number are the transmission build date, in Julian date format. An example of a transmission identification number would be : 101510492P52119684AA. The first three digits ( 101 ) of the identification number equal the day of the year, in this case 101 equals April 11. The fourth digit ( 5 ) of the identification number equals the calendar year, in this case 5 equals 2005. So 1015 equals April 11, 2005.

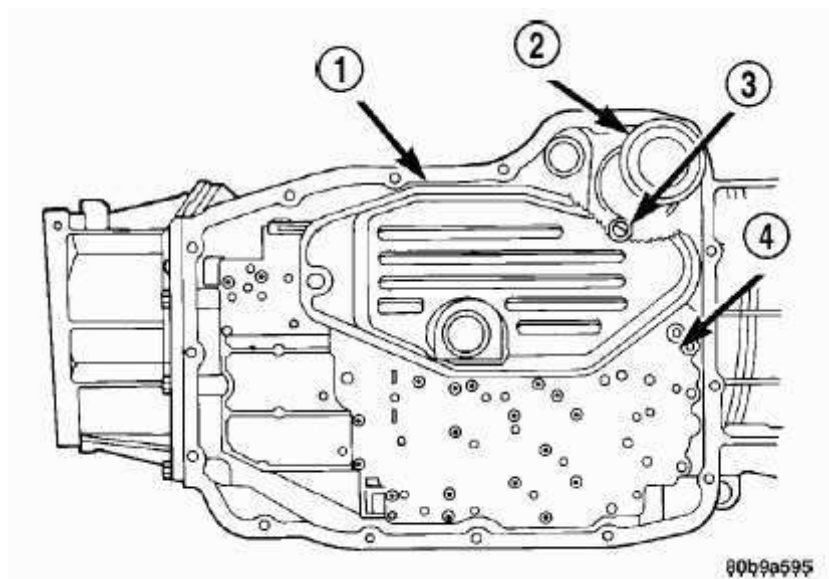
FIGURE 2 - Transmission Filters - 4X4 Shown

The delayed engagement and MIL condition (DTC's) may be caused by a suspect transmission cooler return filter with a part number of 04799662AB. A suspect 04799662AB cooler return filter may cause the transmission sump filter to split at its plastic-to-metal crimp. If the transmission sump filter becomes split at the crimp, then one or more of the above DTC's may also occur.

NOTE: All cooler return filters with the “AB” suffix (04799662AB) are suspect. The above condition may be corrected by replacing a suspect “AB” filter with a new cooler return filter whose part number is 04799662 (with no suffix or with a suffix that is other than the “AB” level), and a new sump filter.

NOTE: BOTH the sump oil filter and the cooler return filter MUST BE replaced in the transmission at the same time. Do not replace one filter without also replacing the other filter.

Use the procedures outlined in TechCONNECT® ( Service Information Tab / 21 - Transmission Transaxle / Automatic - 45RFE 545RFE / Fluid / Standard Procedure / Fluid and Filter Replacement) to replace BOTH the transmission cooler return filter and the transmission sump oil filter.
