## TORQUE CONVERTER CLUTCH NOT ENGAGING &/OR DTC P0741 OR P1744

### TECHNICAL SERVICE BULLETIN

Reference Number(s): 03-12-3, Date of Issue: June 23, 2003

FORD: 1996-2003 TAURUS, WINDSTAR

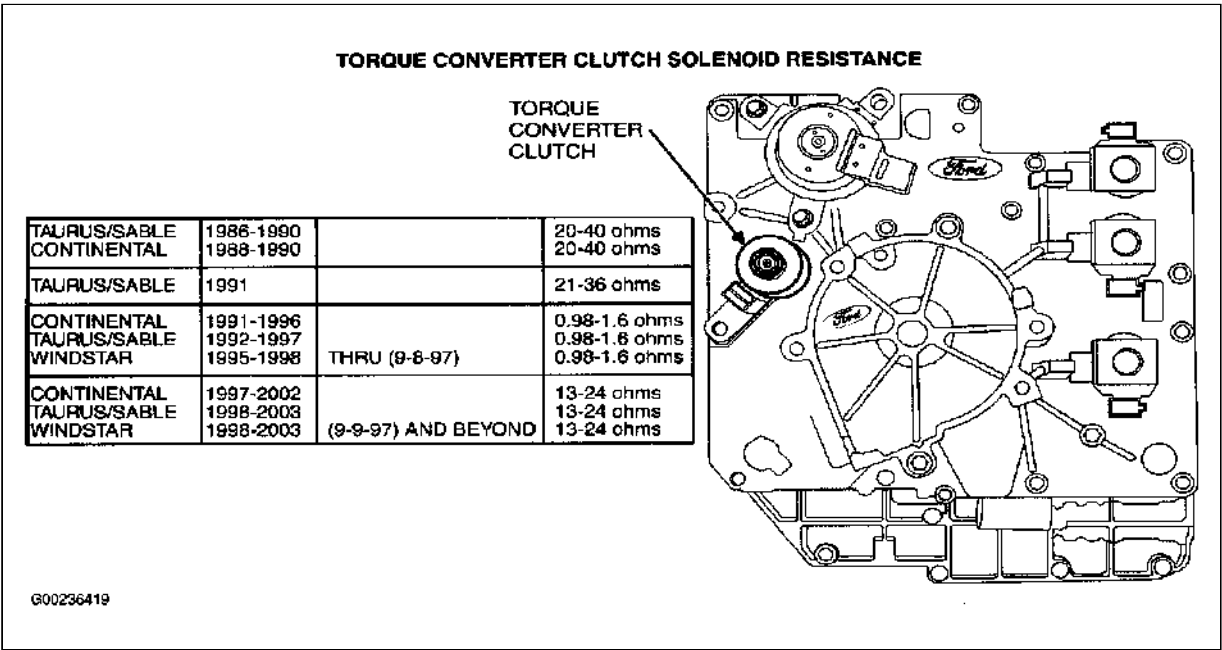
Fig : Torque Converter Clutch Solenoid Resistance Chart

1. For DTC P0741 and P1744, perform Pinpoint test "C" in Section 307-01 of the appropriate Taurus/Sable, Windstar or Continental Workshop Manual and refer to TCC Solenoid Resistance Chart (Figure ) for correct TCC resistance.
