| <b>6.0L—BUILT ON OR BEFORE 9/29/2003—DTCS P006A OR P132B—LACKS POWER, SURGE, OR FLUTTER AFTER FIELD SERVICE ACTION 06E17</b> | <b>TSB 06-24-6</b> |

2003-2004 Excursion, F-Super Duty

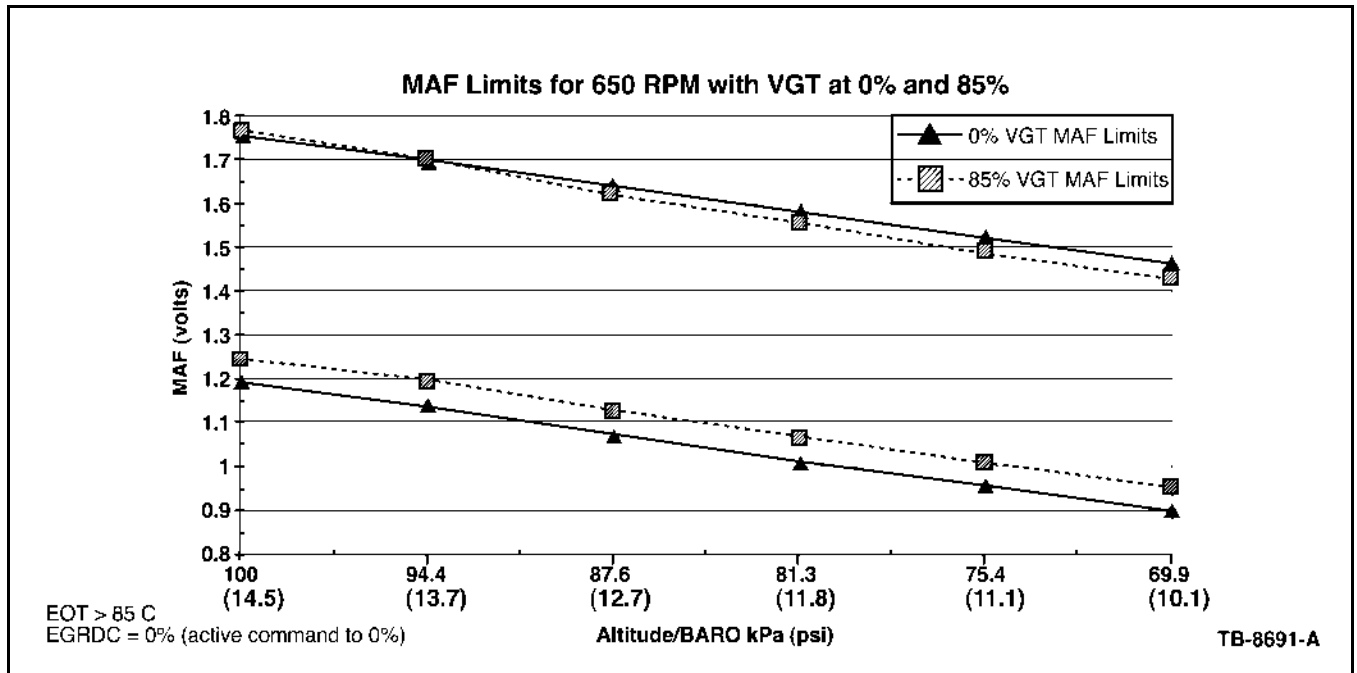
Figure 1 - Article 06-24-6

- (6) 1200RPM VGTDC=85%
  - c. Compare the voltage to Figures 1 and 2. Outside of MAF limits and/or recorded value is lower than limits, possible causes:

- (1) MAF sensor
    - (2) Air leak between MAF sensor and turbo
    - (3) Aftermarket Air Intake system
    - (4) Leaking EGR O-ring or gasket
    - (5) Exhaust restriction

- d. Compare the voltage to Figures 1 and 2. Recorded value is higher than limits, possible causes:
    - (1) MAF sensor
    - (2) Air Leak in the charge air cooler (CAC) system

- (3) Dirty Air Filter
    - (4) Aftermarket Air Intake System
  - e. Verify the MAP/BARO correlation. Are they within 1.0 psi (6.9 kPa) of each other? If not, follow the appropriate PPT diagnostic and repair.
