2000 Saturn LS2 3.0L Eng VIN R

**SERVICE ENGINE SOON (SES) TELLTALE ILLUMINATED WITH DIAGNOSTIC TROUBLE CODES (DTC'S) P0171, P0172, P0174 AND/OR P0175 (REFER TO DIAGNOSTIC PROCEDURE IN THIS BULLETIN AND REPLACE MASS AIR FLOW [MAF] SENSOR, IF NECESSARY)**

**TECHNICAL SERVICE BULLETIN**

Reference Number(s): 01-06-04-016A, Date of Issue: December 06, 2004

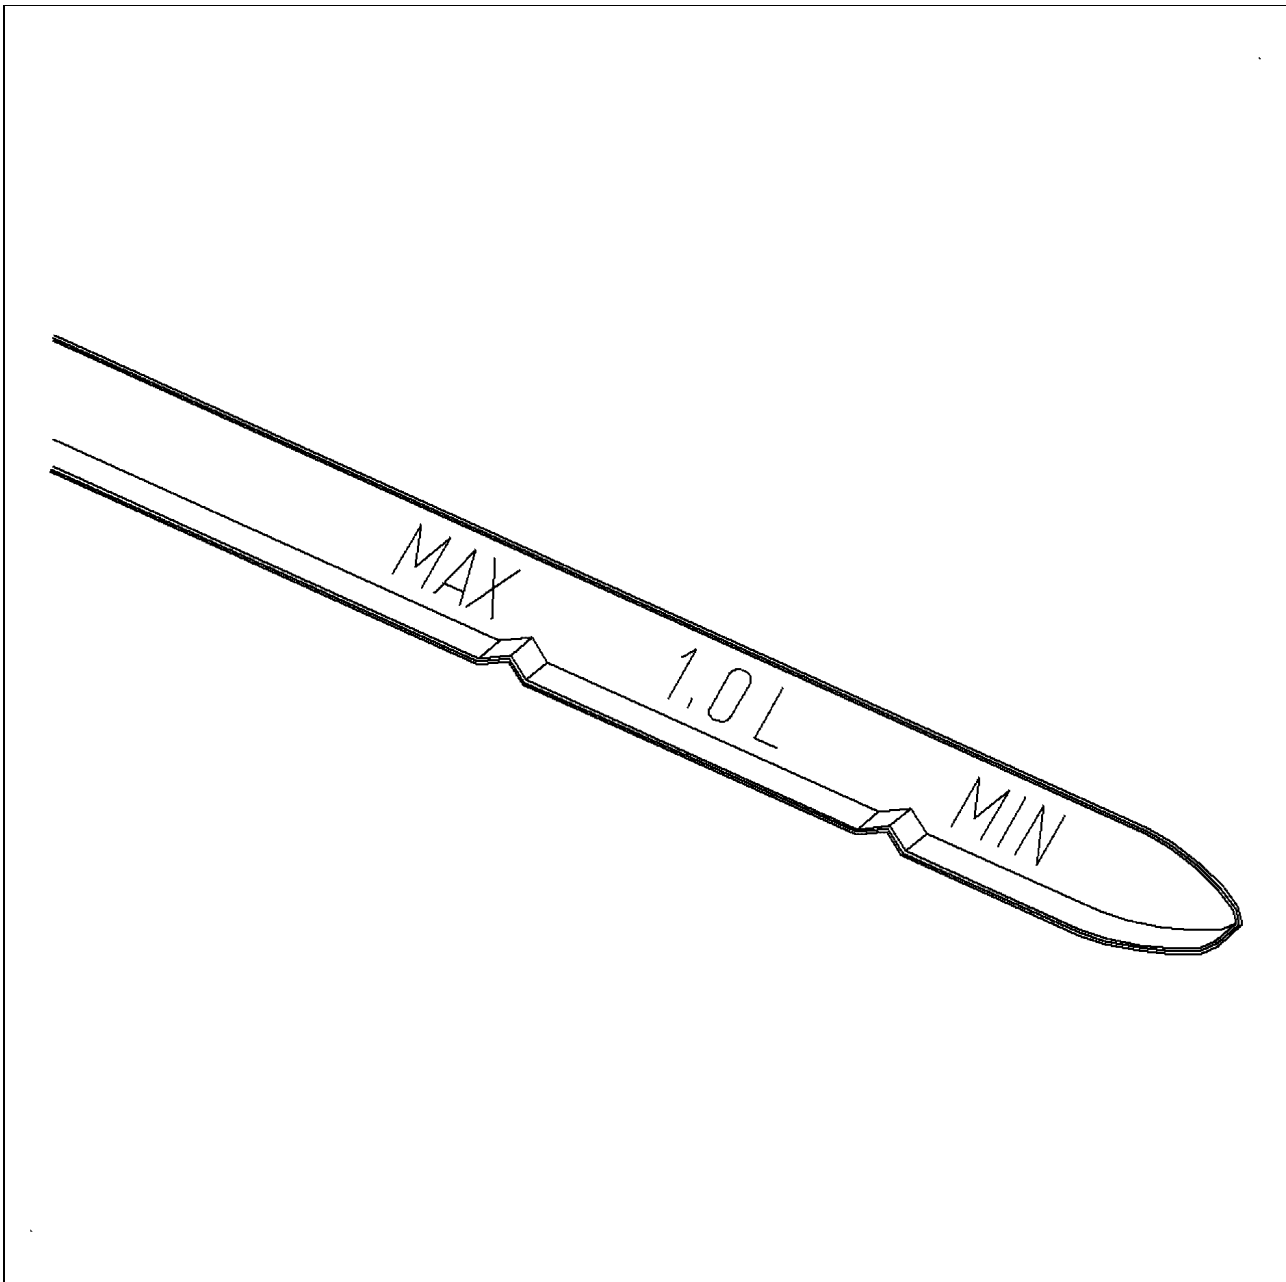
Fig : Crankcase Dipstick

This condition may be caused by one or more of the following: debris on MAF sensor causing an incorrect reading, improper oil level, low or high fuel pressure, Engine Control Temperature (ECT) Sensor reading inaccurate, EVAP system problem and/or poor fuel quality.

2. Check for proper engine oil level.
  1. If oil level is correct, proceed to next step.
  2. If oil level is too high, perform the following:
    1. Drain oil to correct level.
    2. Clean oil from throttle body and air tubing leading to oil separator.
    3. Replace MAF sensor. (Refer to step 5.)
3. Check fuel pressure by performing "Fuel System Pressure Test". Refer to "Fuel System Diagnosis" (SI Document ID #1094549 [2000], 1073922 [2001 and 2002] or 1241266 [2003]) in the Fuel System section located in the applicable Saturn L-Series L81 Engine Service Manual.
  1. If fuel pressure is correct, proceed to next step.
