## A/T - No Reverse/3rd or 5th Gear/MIL ON/DTC P0776

**Bulletin No.:** 09-07-30-012F

**Subject:** No Reverse, 3rd or 5th, Check Engine Light Illuminated, DTC P0776 (Replace 3-5 Reverse Clutch Plate (Waved)

All Equipped with 6T70/75 6-Speed Automatic Transmission (RPOs MH2, MH4, MH6 or MY9)

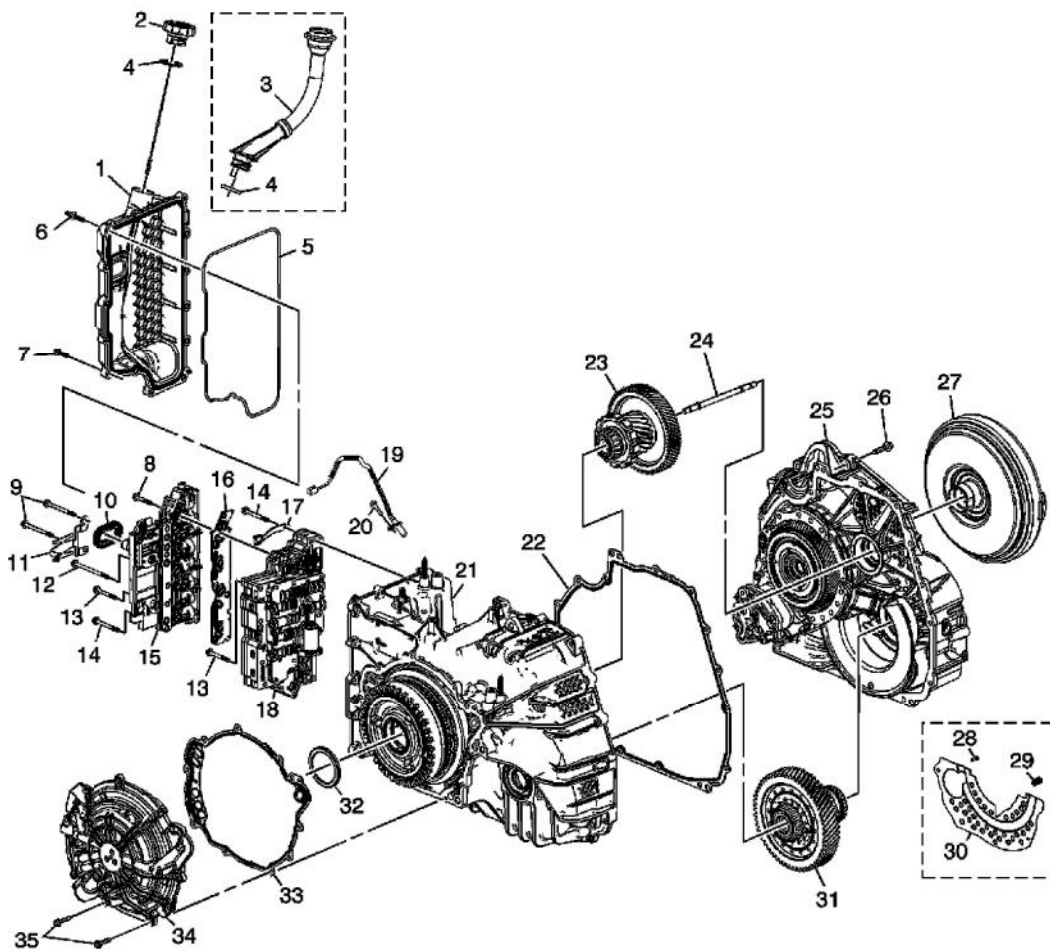
Debris generated by the condition must be cleaned from the entire transmission and the pump fluid filter (201) and the control solenoid filter plate (16) must be replaced. Failure to separate the case halves, disassemble the transmission, clean the debris and replace the pump fluid filter (201) and the control solenoid filter plate (16) could lead to repeat transmission damage and repairs.

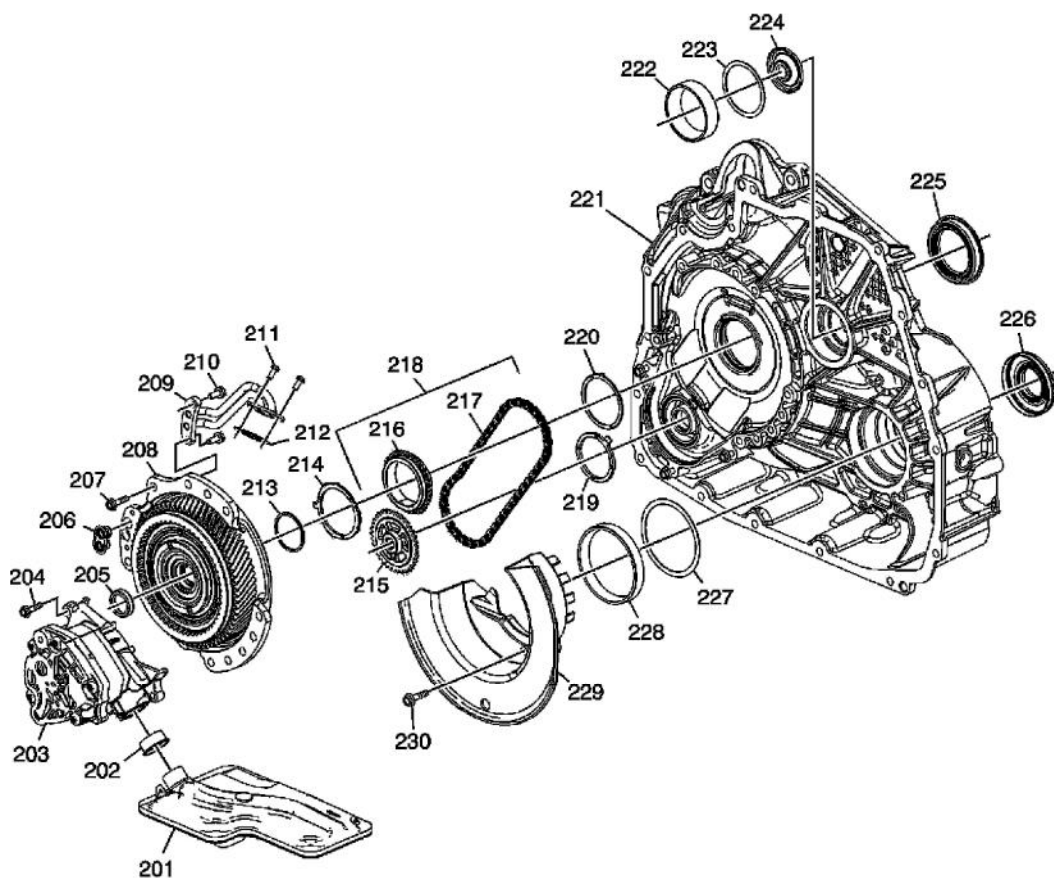
A broken 35R wave plate can generate varying amounts of debris inside the transmission. In most cases this debris has not passed through the pump fluid filter (201) damaging the pump, valve bodies or torque converter. This debris can be cleaned and the transmission successfully repaired.

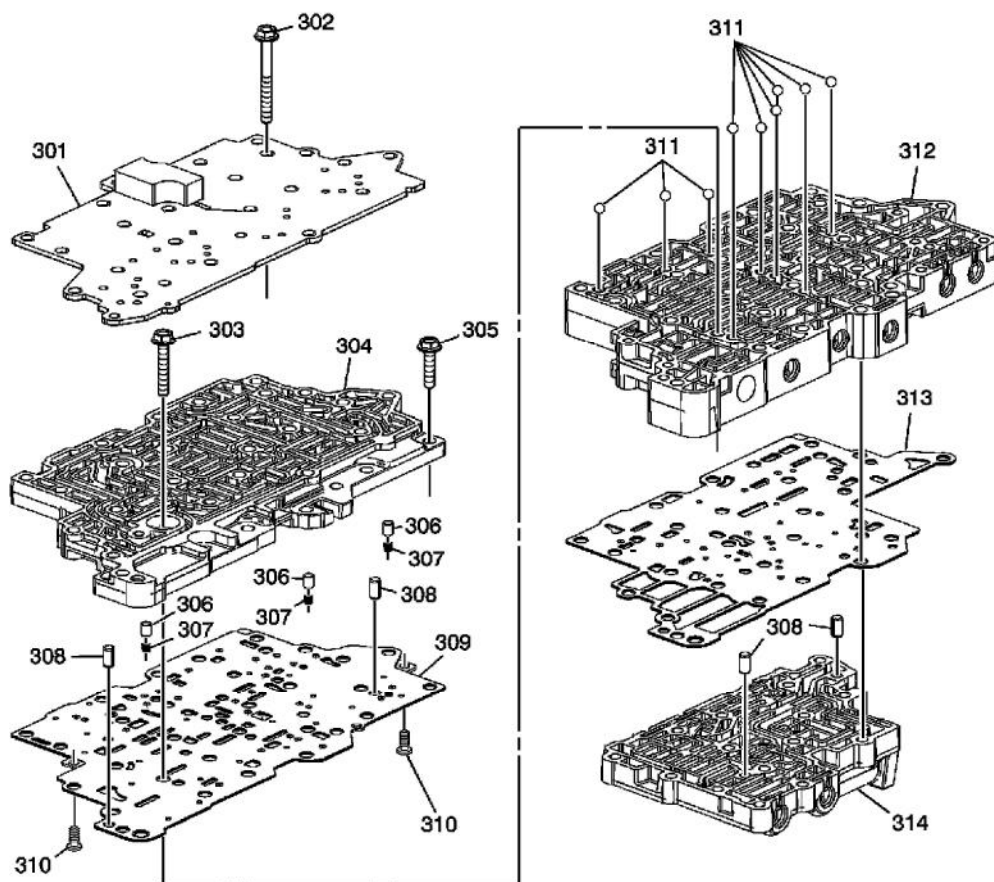
2007-2008 applications - when assembling these transmissions, inspect the control valve channel upper plate (301) to make sure that it contains the slot as indicated above. Plates installed that do not include this slot may result in DTCs.
