# Service Bulletin

Bulletin No.: 11-06-04-007C

Date: November, 2012

**Subject:** Diagnosis and Repair - Malfunction Indicator Lamp (MIL) Illuminated, Reduced Engine Power Message Displayed, DTC P2135 Set

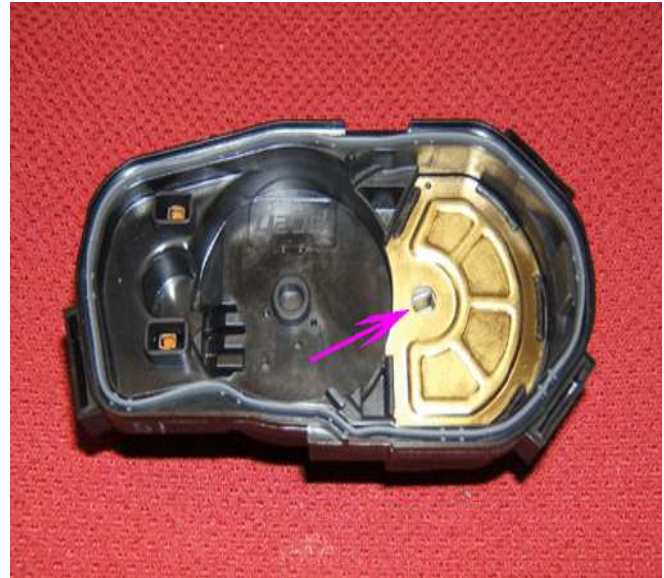
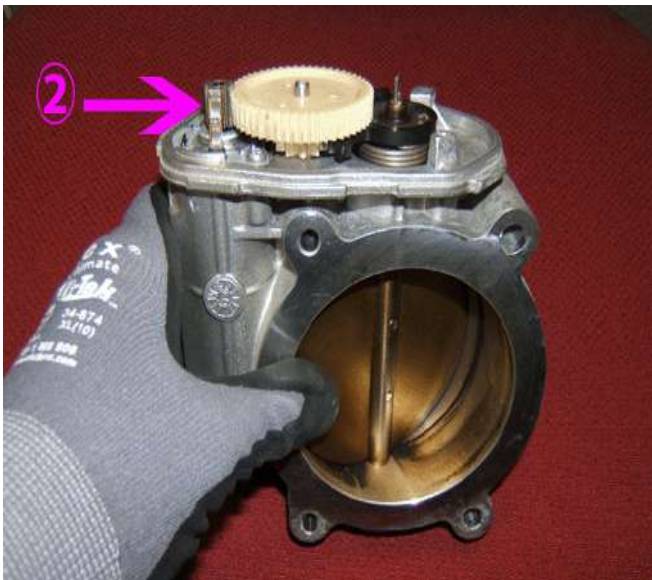
14. Observe the TP sensor cover for missing female throttle actuator motor terminals (1). Verify that the female throttle actuator motor terminals HAVE REMAINED in the TP sensor cover and HAVE NOT been retained on the throttle actuator motor male terminals (2). Discard the old TP sensor cover, gasket and terminals.

⇒ If one or both of the TP sensor cover female throttle actuator motor terminals HAVE BEEN retained on the throttle actuator motor male terminals (2), remove and discard those female terminals.

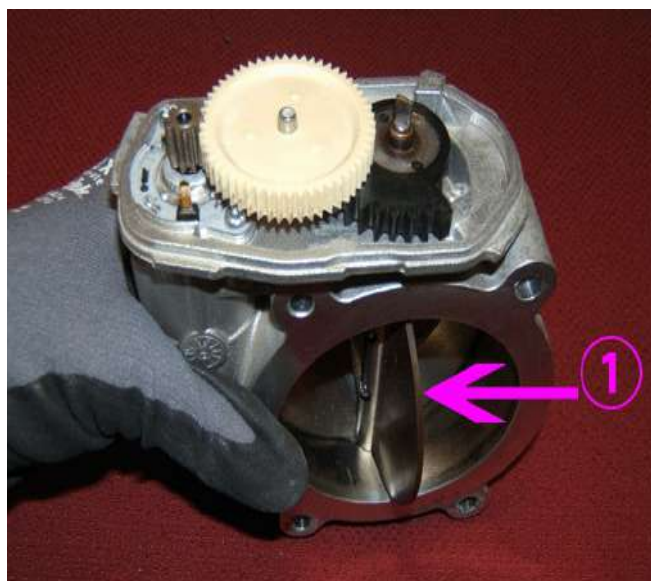
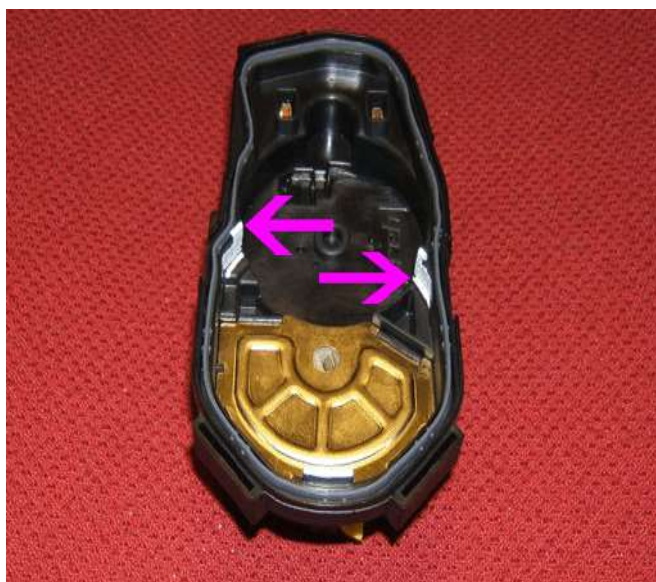
**Notice:** The three TP sensor cover alignment tabs are highlighted in white for identification purposes only.

18. Verify that all three of the TP sensor cover alignment tabs are present and are not damaged.
19. Grasp and hold the throttle body in the previously hand held upward position. Lightly depress the intermediate gear to verify that it is fully seated and the gears are engaged.
