# Service Bulletin

Bulletin No.: 16-NA-383

**Subject:** Information on Rough Idle, Crank No Start, Extended Crank or Misfire Due to Excessive Carbon on Top of Valves or Sticking Valves, Malfunction Indicator Light (MIL) Illuminated - DTC P0300, P0301, P0302, P0303, P0304, P0305, P0306, P0307, P0308 Set

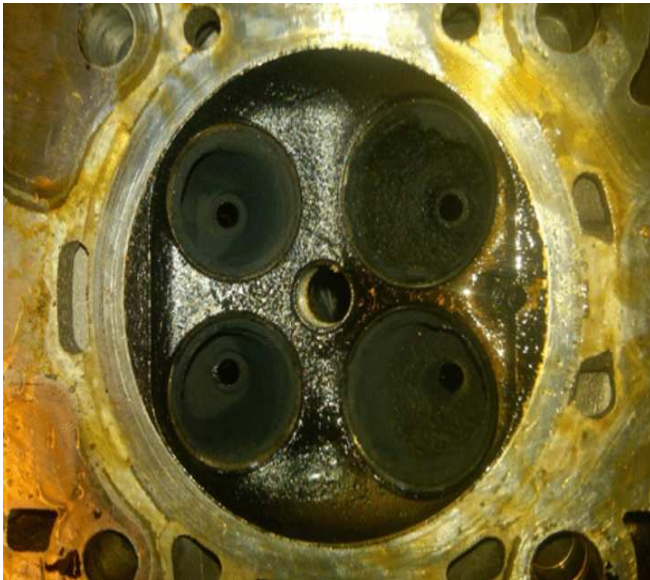
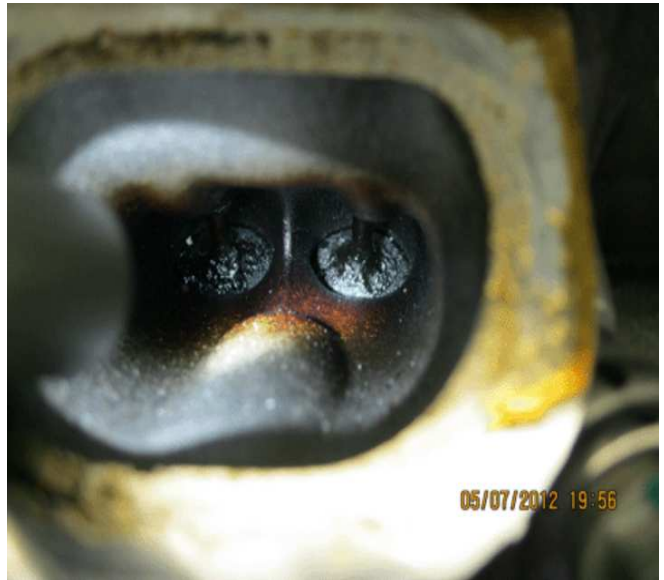
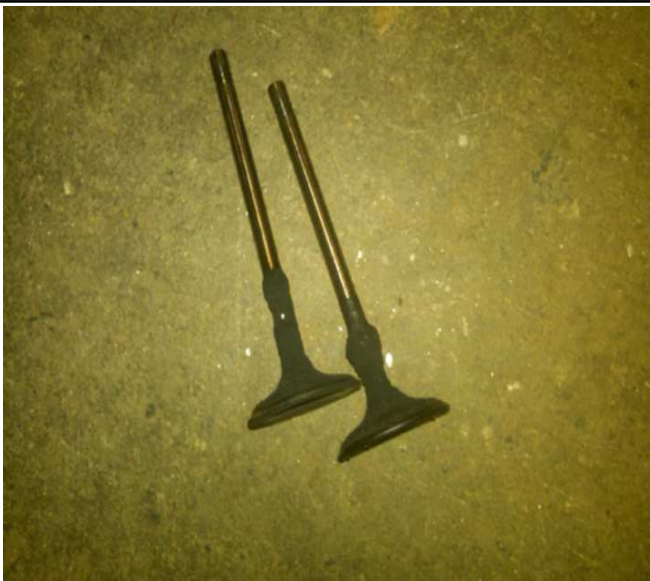
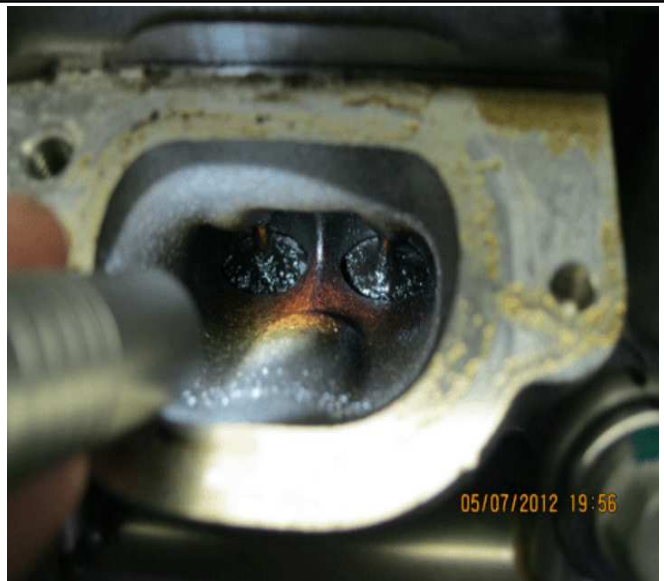
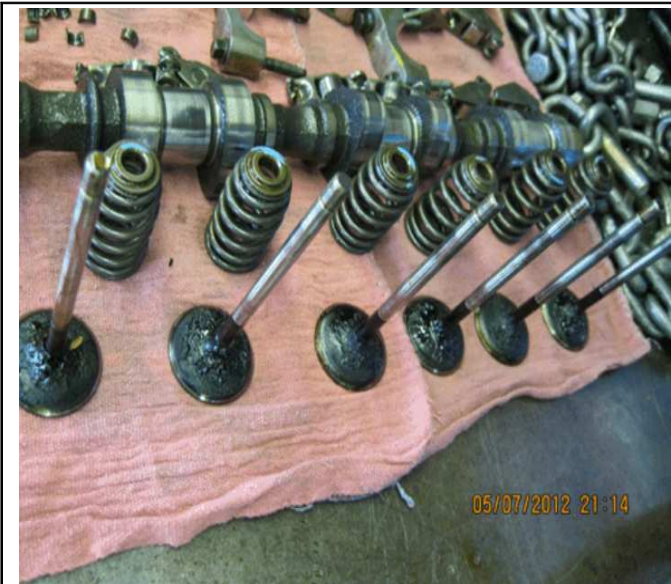
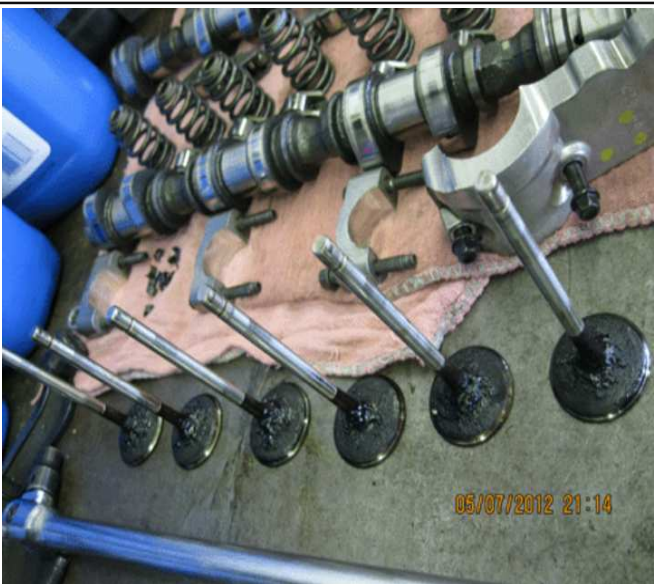
| Involved Region or Country | North America |
|---|---|
| Cause | <p>This condition may be caused by major carbon build-up on the intake and/or exhaust valves due to fuel contamination or incomplete burning of the fuel as shown below, so the misfires should not have appeared until accumulating at least 8,000 km (5,000 mi) or more.</p> |

The graphics below may show typical carbon build-up during engine disassembly and inspection of the cylinder heads:

- If there is no sign of valve damage or cam followers that are out of place, perform the following procedure to free up sticking valves and to remove carbon from the valves and pistons.
- If valve damage is present or if there are cam followers that are out of place, perform engine mechanical repairs as necessary to correct the concern and then perform the procedure below to prevent the concern from returning.
- Perform an upper engine and valve cleaning procedure.
- Below are examples of valves that have gone through a Top Engine cleaning procedure.
