# Service Bulletin

Bulletin No.: 18-NA-367

**Subject:** Diagnostic Tip for Malfunction Indicator Lamp (MIL) Illuminated with DTC P305F, P058B and/or P058D

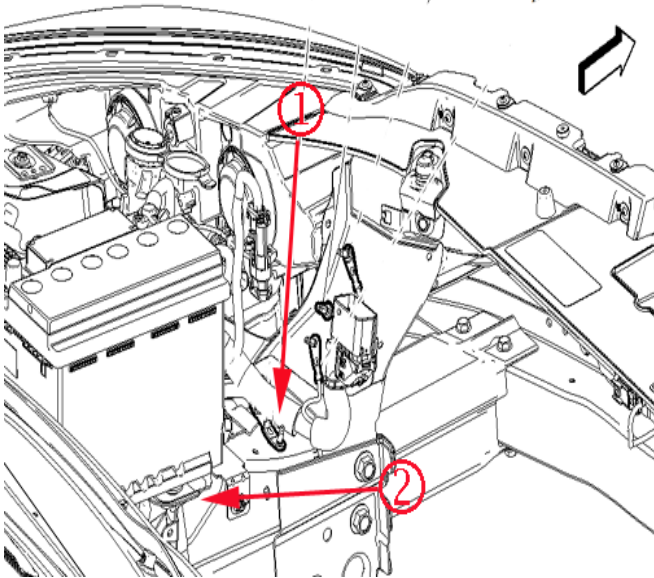
4005667

Inspect the following if DTC P305F has been set:

1. Check state of health of auxiliary battery with the GR8 tester. Not just a state of charge check.
    - If low, replace the battery, clear codes and re-check.
    - If good, proceed to step 2.
  2. Check ground resistance from the Dual Battery Isolation Module (DBIM) to G103. Wiggle the harness (1) and negative battery terminal connections during test to look for varied resistance values.
    - If resistance is greater than 0.5 ohms, or changes more than 1 ohm, then inspect ground connections and/or splice in the harness about 1.5 ft. from the connector end.
- ⇒ Fix poor connections, clear codes and re-check.
- If resistance is less than 0.5 ohms, proceed to step 3.
3. Verify the engine harness is not pinched underneath the main battery tray (2).

**Note:** The DBIM is located on the fuse block assembly. If found the cause of the concern, the Battery Distribution Fuse Block must be replaced.

4. Replace the battery distribution fuse block and wiring harness connector, clear codes and re-check.

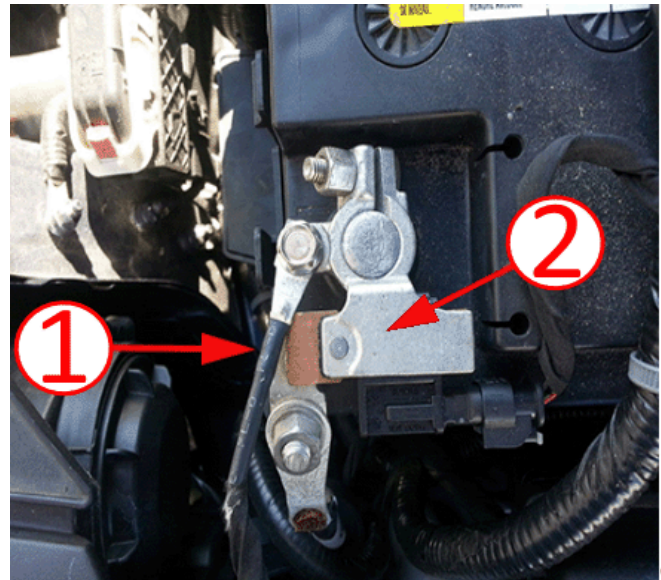
5148609

Inspect the following if DTC P058B and/or P058D is set current or in history:

1. Inspect the orientation of the grounding ring for circuit 150 (1) to the B110 Battery Sensor Module (2).
