## PIP5495G Check Engine Light On With P0299 Or P0234

| Cause: | Misdiagnosis Leading to Returned Turbochargers with NTF |

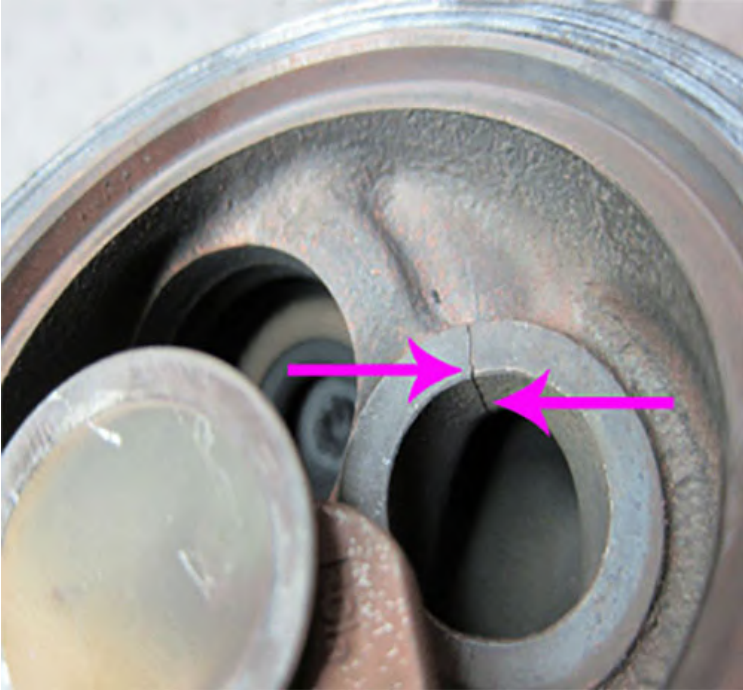
Crack(s) at the wastegate valve port (this is normal and does not affect performance)

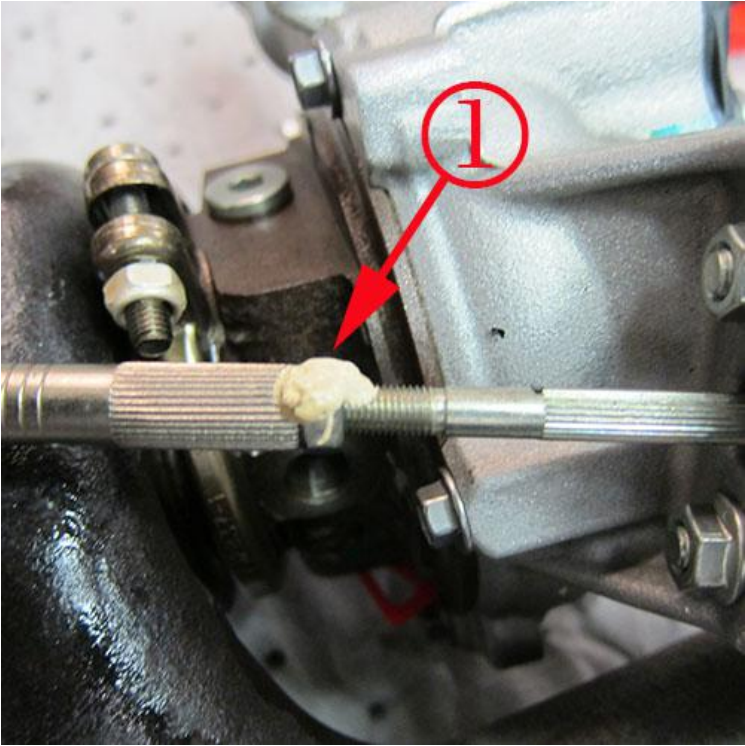
If the tamper paint seal is broken or missing, check the vehicle for any additional sign of modification to the induction, exhaust, or engine calibrations as this may indicate an attempt to adjust the wastegate arm to modify the powertrain operation.

If found, review the powertrain warranty status with your service manager prior to performing repairs

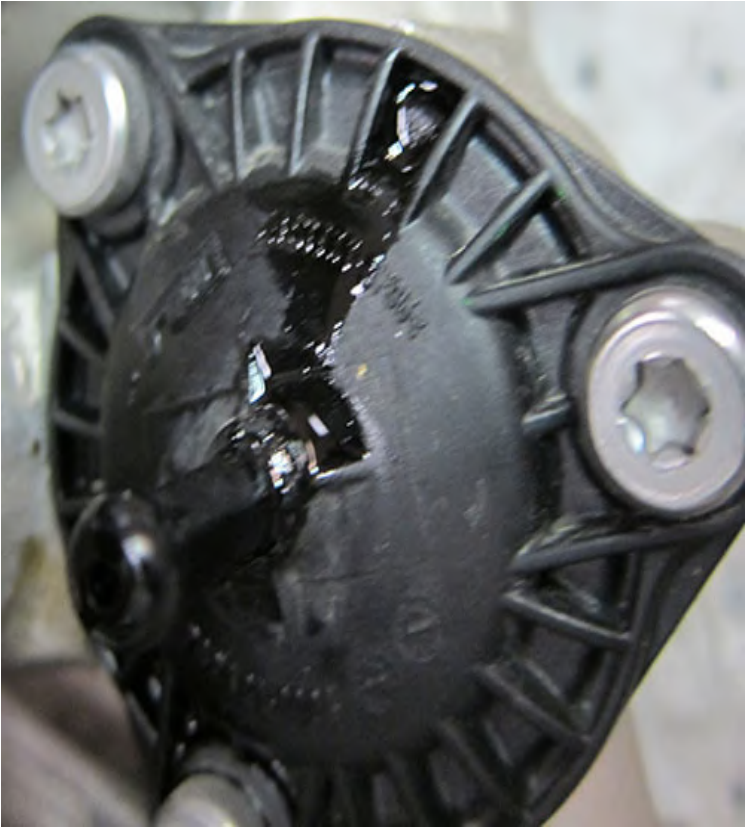
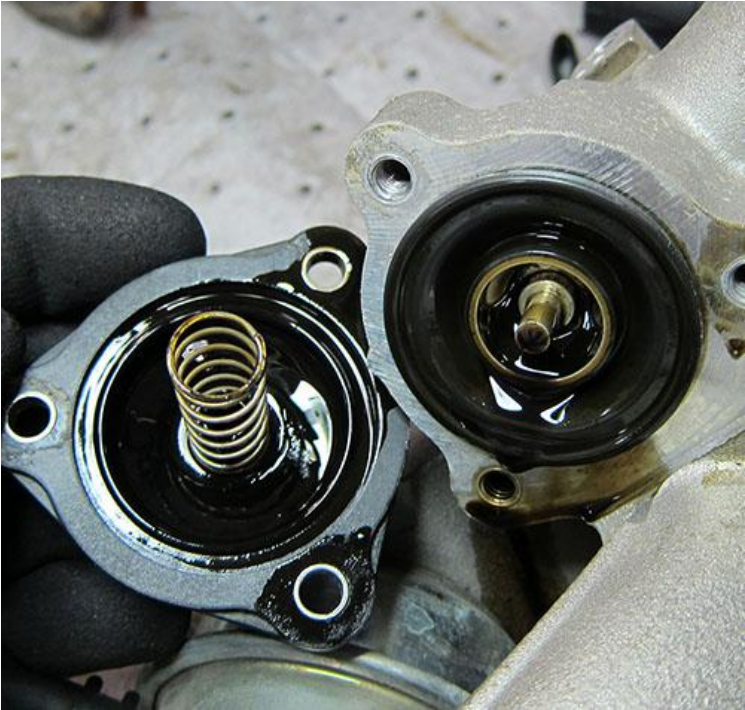
Bypass (recirculation) valve cover port broken or water/oil found inside the valve (clean the components, if necessary replace bypass (recirculation) valve assembly - released for service)

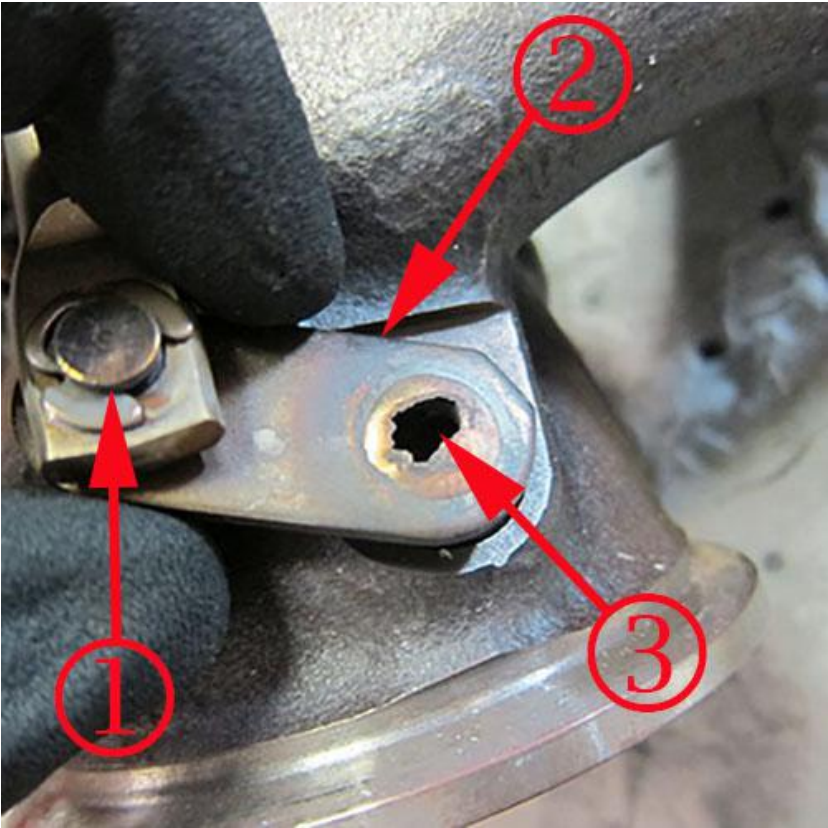
Replace the turbocharger if P0299 is set and at least one of the following is present:  
If the following failures are identified, it is not necessary to perform the Turbocharger Boost Control Test.  
Disconnected wastegate lever arm (crank) (2) from the shaft (3).

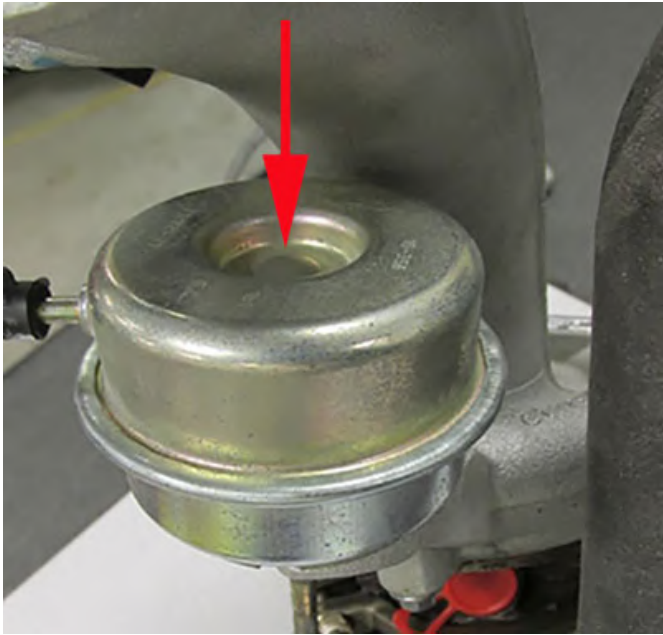
If the lever wiggles with little effort while the actuator rod remains static, the pre-load is insufficient and the turbocharger must be replaced.  
The original equipment wastegate actuator found on 2011 and 2012 model years shown below, has a recessed stop at the head of the actuator.  
The updated design actuator show below has a stop that is not recessed and allows 5mm more travel in the closed direction.  
With this updated design, it is very unlikely that an insufficient preload issue exists.  
Original equipment actuator is found on 2011 and 2012 model years.

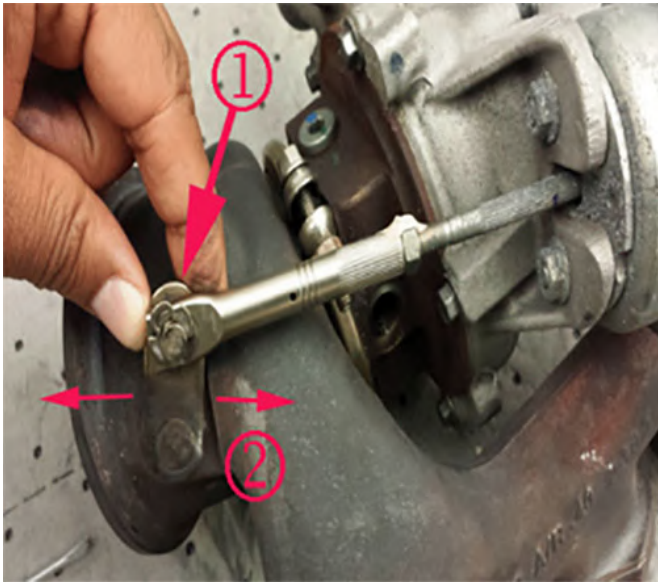
Wastegate Preload Inspection.

Disconnected wastegate lever arm pin (1) from the lever arm (crank) (2).  
Wastegate valve/linkage seized (cannot move).  
Turbine wheel not rotating, turbine wheel shaft broken or missing wheel nut.  
If wheel nut is missing, be sure to locate prior to turbocharger replacement.  
If the Wastegate lever arm (crank (2) is bent, performing the Turbocharger Boost Control Test is required.  
Insufficient wastegate preload.  
Wastegate lever arm (1) moves with little effort in the direction as shown (2) while the actuator rod remains static, see picture below "Wastegate Preload Inspection".

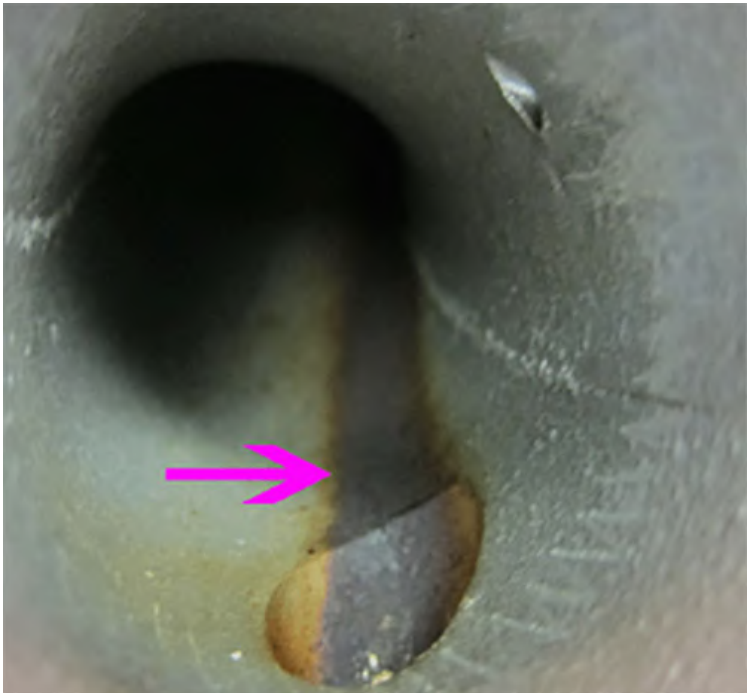
Notice: The view shown below indicates **NORMAL** oil staining in the turbocharger outside air inlet. This dry stain does not represent an oil leak.

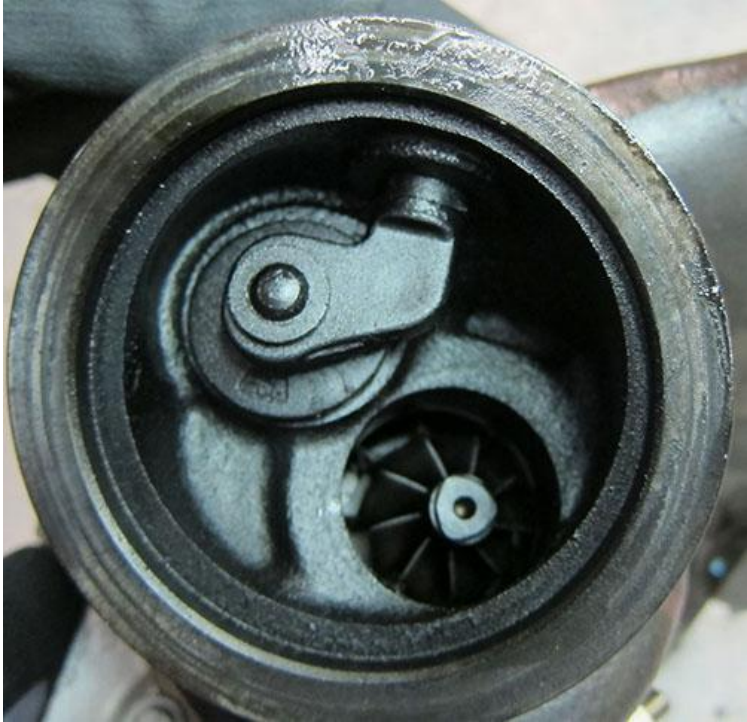
Inspect for the presence of oil in the exhaust system.

If oil is present in the exhaust system, then inspect the turbocharger turbine and compressor wheels to be sure that they are not broken off.

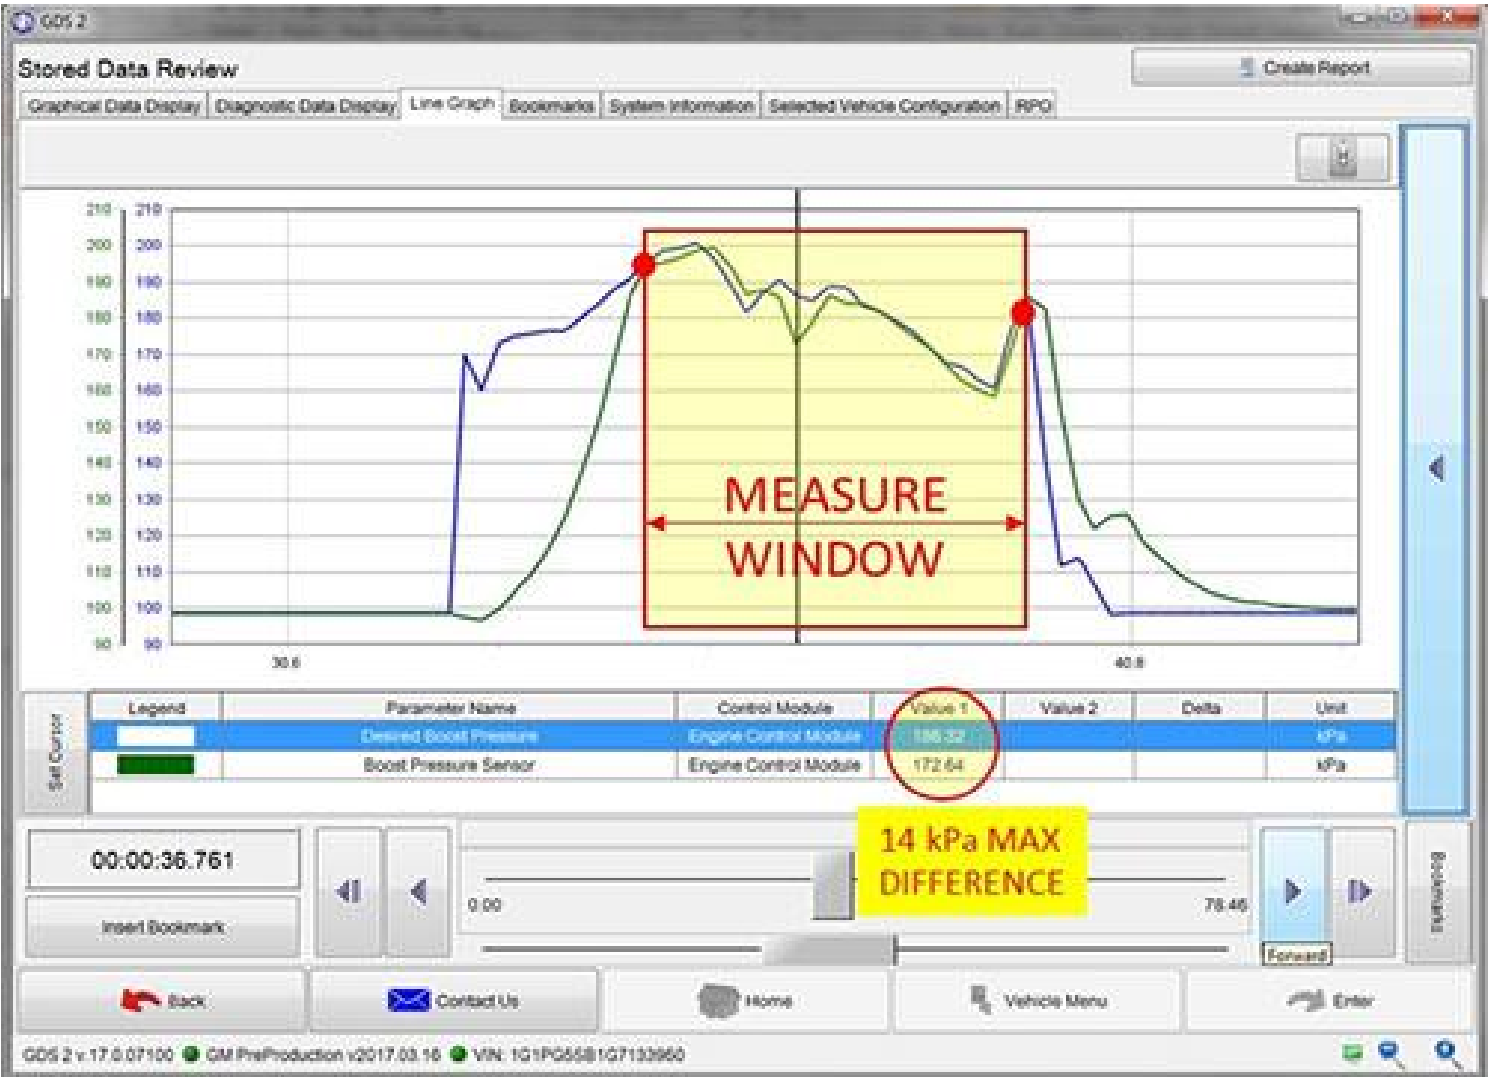
Example of normal turbocharger wastegate operation:  
In this example, notice that the measure window begins once the Boost Pressure Sensor reading (Green) meets the Desired Boost Pressure reading (Blue) and ends when the APP is released per the testing instructions.  
The Boost Pressure Sensor reading (Green) closely tracks the Desired Boost Pressure reading (Blue) indicating normal Turbocharger

operation.

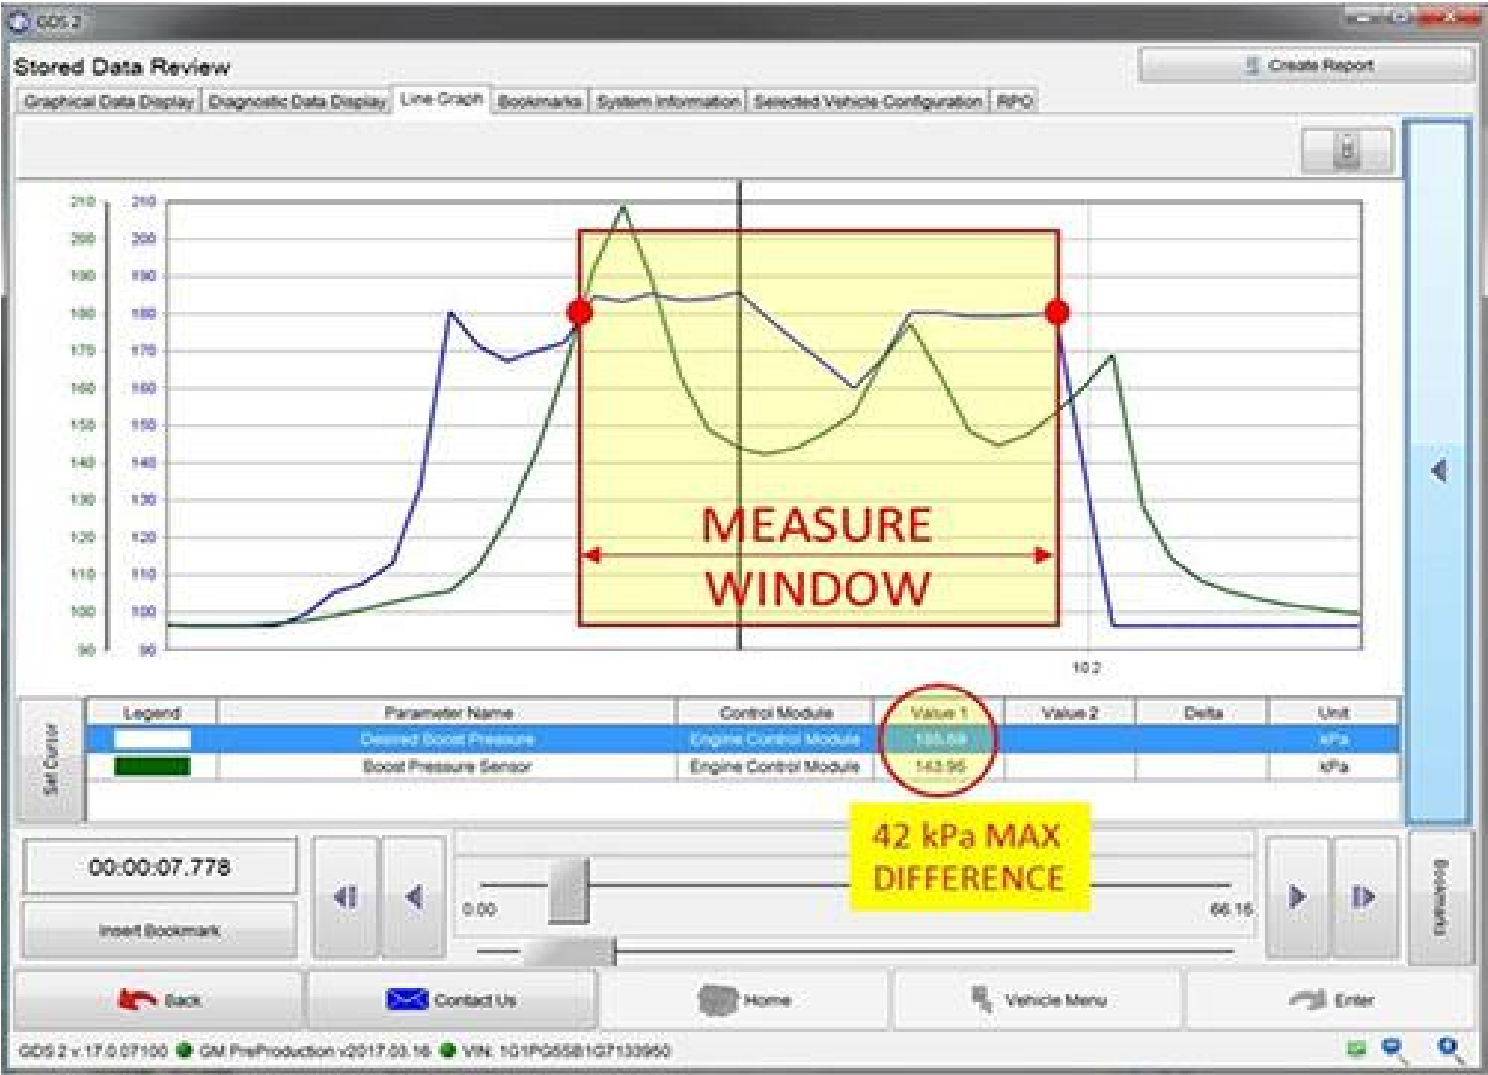
Example of a malfunctioning turbocharger wastegate:

In this example, notice that the Boost Pressure Sensor reading (Green) moves thru and well above the Desired Boost Pressure reading (Blue).

As the abnormally high pressure is corrected by the management system, the Boost Pressure Sensor reading (Green) over reacts and dips well below Desired Boost Pressure reading (Blue).

A difference of 14 KPA (2 PSI) between the Boost Pressure reading (Green) and the Desired Boost Pressure Sensor reading (Blue) Indicates a Malfunctioning Turbocharger.

9. Utilize the Print Screen Function to take a screen shot of GDS2 showing the line graph.
10. Replace the turbocharger if the difference within the Measured Window is more than 14 KPA (2.0 PSI) as shown in the examples.
