#PIT4749A: Fuel Gauge Inaccurate DTC P2066 And/Or P2636 - keywords dual empty full gauge inoperative IPC level out P1682 pump relay stall SES tanks transfer - (Mar 10, 2009)

Subject: Fuel Gauge Inaccurate DTC P2066 and/or P2636

2007-2009 Chevrolet Silverado 3500 Chassis Cab

Models: 2007-2009 GMC Sierra 3500 Chassis Cab

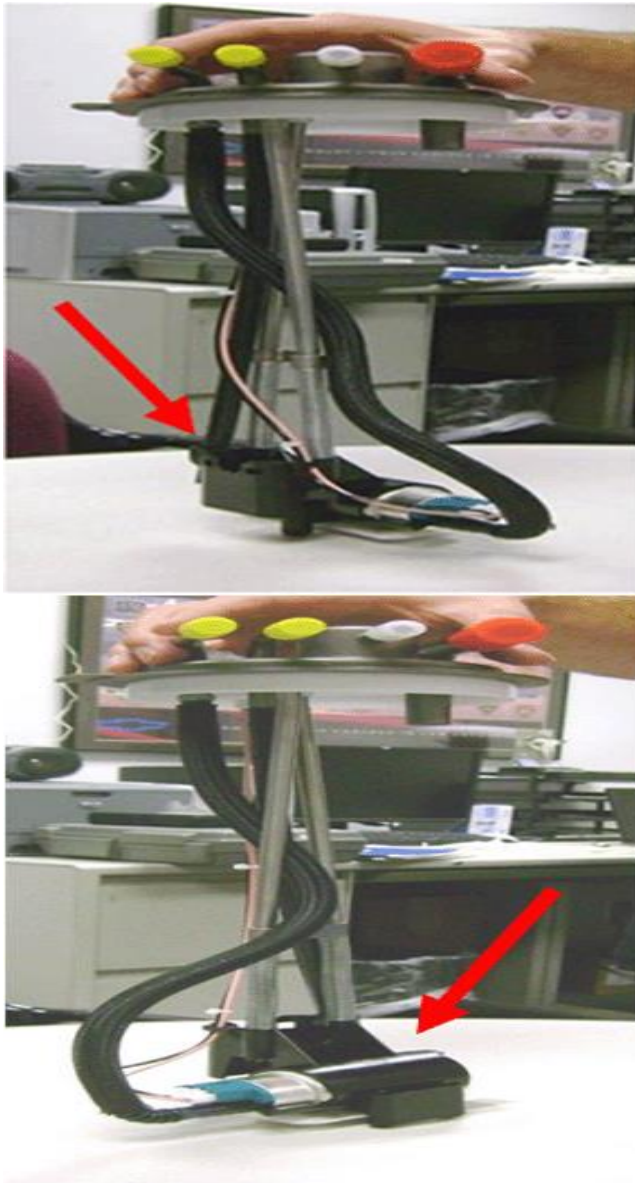
Some owners may comment of the fuel gauge being inaccurate and/or the SES MIL illuminated. When checking for DTC's there may be a P2066 and/or P2636 stored in the ECM. This concern could be caused by the rear tank sender float arm contacting the side of the fuel tank or fuel filler spud inside the tank. This prevents the float arm from moving when fuel is transferred out of the rear tank. Because the float arm does not move, the ECM does not sense the fuel level decreasing. This can lead to an inaccurate fuel gauge reading on the IPC as well as DTCs to set in the ECM.

The float arm may be in contact with the side of the tank or fuel filler spud due to the lower portion of the fuel sender assembly that contains the fuel pump and sender float arm rotating on the two metal spring rods. Shown below are pictures of the lower part of the sender twisted to the left and right

Engineering is aware of this concern. Currently, the only repair is to position the lower part of the sender so the float arm will not contact the side of the fuel tank or fuel filler spud and clamp it into position to prevent from twisting. Using two small hose clamps, open the clamps up all the way to install one over each spring rod. Slide the hose clamp to the top of the sender assembly and install around the plastic boss that retains the spring rod. With the lower part of the sender in a position to prevent the float arm from any contact, tighten the hose clamps. See picture below for detail.
