EC06-002a

## MIL "ON" WITH DTC U1000 OR U1010 STORED IN ENGINE CONTROL UNIT

**APPLIED VEHICLES:** 2002-2004 I35 (CA33)  
2002-2006 Q45 (F50)  
2004-2006 QX56 (JA60)  
2003-2006 FX (S50)  
2003-2006 G35 (V35)  
2003-2004 M45 (Y34)  
2006 M (Y50)

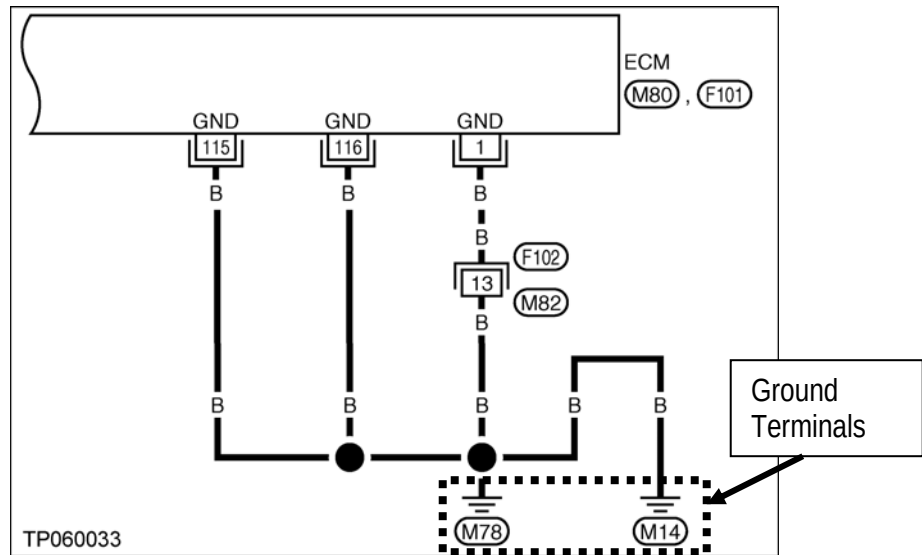
Figure 1

3. Make sure all ECM ground terminal connections are clean and tight as follows:
  - a. Make a list of the ground terminals for your vehicle. Refer to the appropriate Service Manual, section EC (Power Supply and Ground Circuits).

NOTE: This is an example only. Your vehicle may be different.

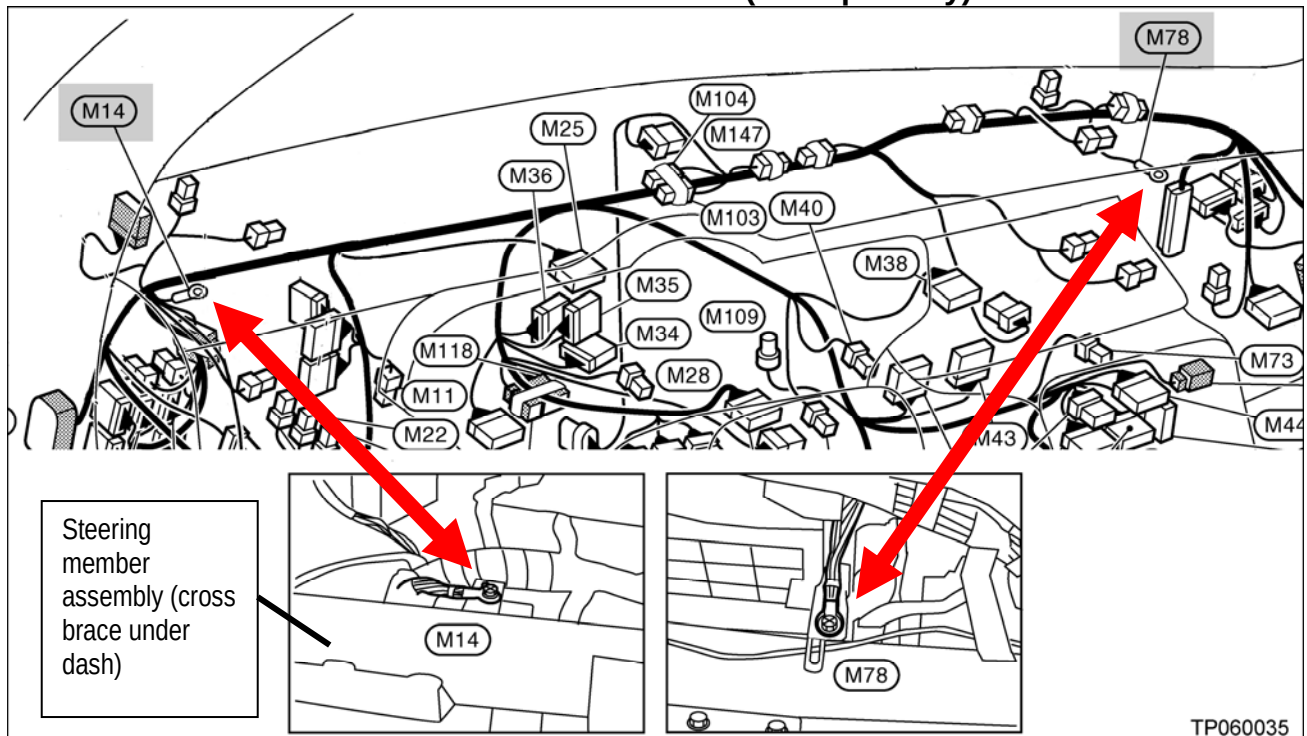
Figure 2

### Ground terminal locations (Example only)

- b. Take your list and go to section PG in the appropriate Service Manual. You'll be able to identify the exact location of the ECM ground terminals you'll need to check.

- c. Now go to the ground terminal(s) on the vehicle and remove the nut or bolt that holds the terminal eyelet(s).
- d. Clean the following surfaces on each ECM ground terminal. This will ensure good contact in the connections.

- Both sides of the eyelet
- Eyelet mounting surface

- Nut/bolt threads.
- Female threads in bolt holes (use the correct size tap).

- e. Reinstall and tighten the nut or bolt that holds the terminal eyelet.

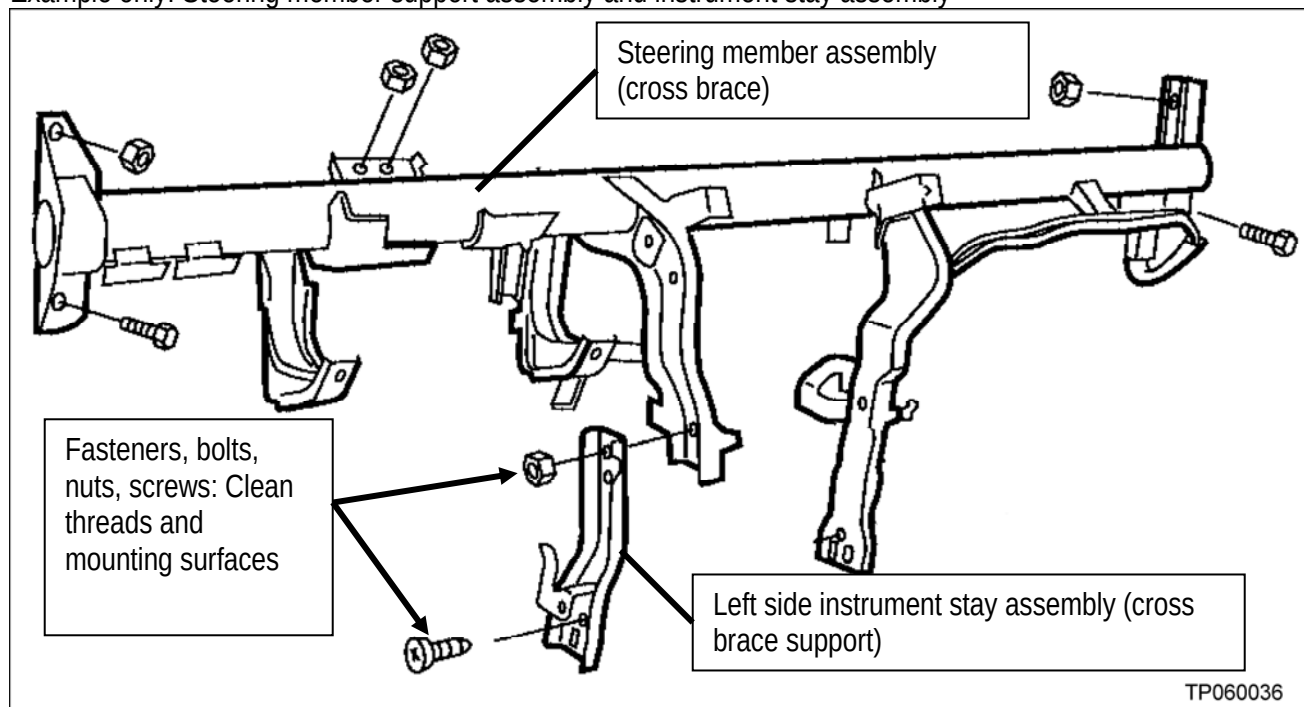
Figure 3

Example only: Steering member support assembly and instrument stay assembly

4. If the ECM ground terminals are attached to the steering member assembly (cross brace under the dash):
  - a. Remove the fasteners (nuts, bolts, screws) that attach the left side instrument stay assembly (cross brace support) to the steering member assembly (see Figure 3).
  - b. Clean the mounting surfaces and fastener threads.
  - c. Reassemble and tighten the fasteners.
