# SERVICE BULLETIN

EC02-018a

## LOW POWER/POOR RUNNING AND/OR MIL 'ON' WITH FRONT O2 SENSOR/TRANSMISSION GEAR DTC STORED

**APPLIED VEHICLE:** 2002 Altima (L31) with QR25DE ONLY

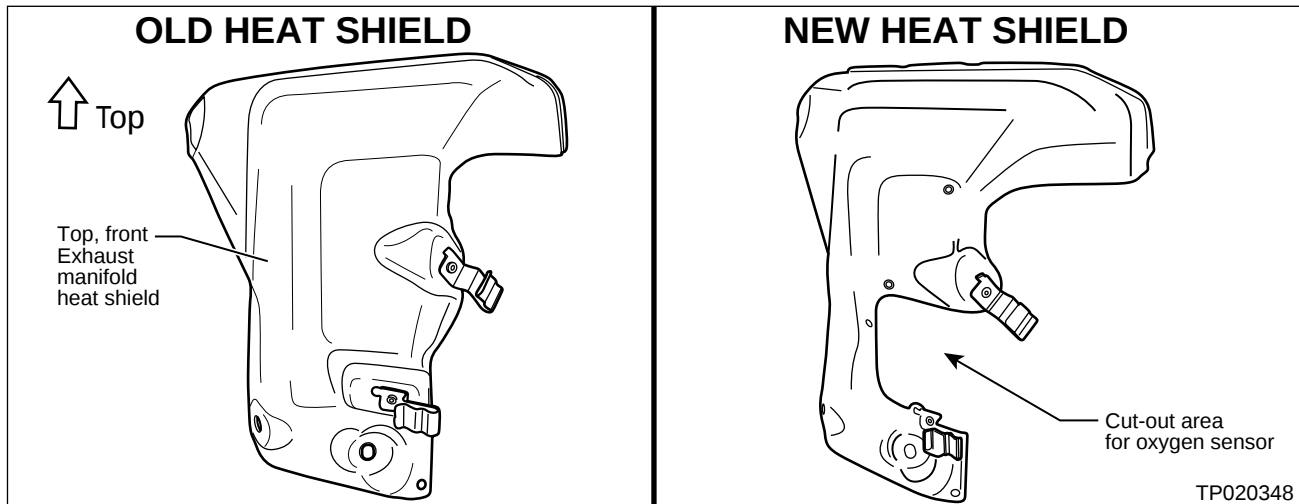
Figure 1a

- A. If the heat shield looks like the one in Figure 1a, perform the QR25 campaign (NTB03-070a or later revision). This includes replacing the heat shield (Figure 1b).

**NOTE:** The new heat shield shown in Figure 1b is an important part of the repair to prolong the life of the replacement oxygen sensor.

- B. If the heat shield looks like the one in Figure 1b, the heat shield does NOT need to be replaced. Go to step 2 (below).

2. Replace the front oxygen sensor with the one listed in the Parts Information table.
3. Use CONSULT-II to Erase DTC P0031, P0132, P0133, P0134, P1144, P0731, P0732, P0733, P0734 from the vehicle's ECM (if these codes are stored).
