SERVICE BULLETIN

Classification: EC04-001	Reference: NTB04-025	Date: February 19, 2004
-----------------------------	-------------------------	----------------------------

2004 MAXIMA AND QUEST (4AT & 6MT MODELS ONLY); MIL ON P0171 / P0174 / P1273 / P1283

APPLIED VEHICLE: 2004 Maxima (A34) with 4-speed A/T and 6-speed M/T
2004 Quest (V42) with 4-speed A/T

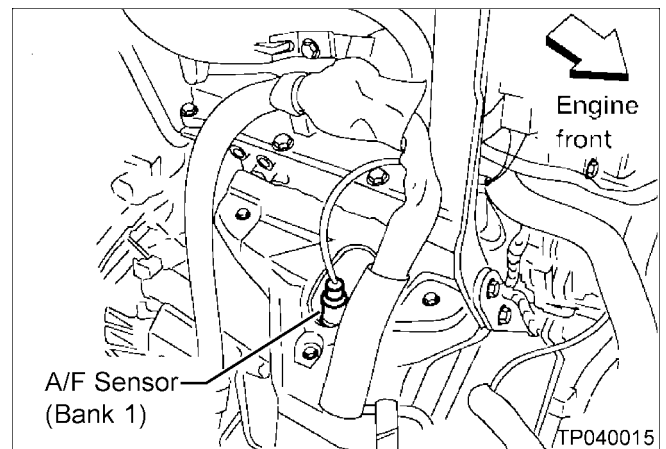
Figure 1

For DTC code(s) P0171 and/or P1273:

- Replace A/F Sensor—Bank 1
- It is located on the side of the engine that is towards the **rear** of the vehicle (see Figure 1)

1. Make sure the engine does not have any intake or exhaust leaks.
 - Use the EC section of the appropriate Service Manual (ESM) and ASIST for intake and exhaust system diagnostic information.
 - If no intake or exhaust system leaks are found, go to step 2.
2. Replace the A/F Sensor (bank 1 or bank 2).
 - The A/F Sensor is located in the exhaust manifold in front (upstream) of the catalyst.

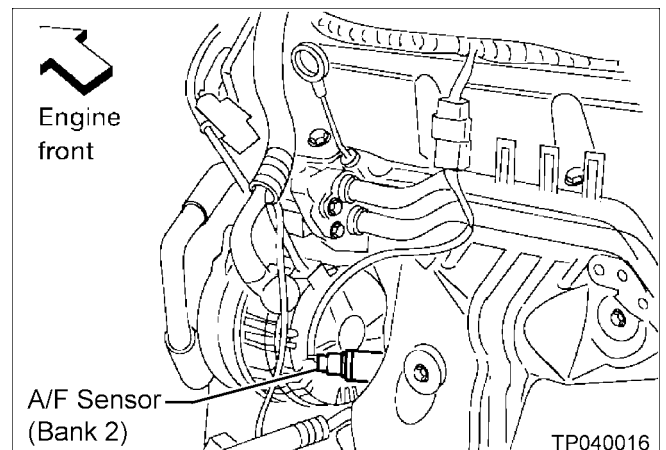
Figure 2

For DTC code(s) P0174 and/or P1283:

- Replace A/F Sensor—Bank 2
- It is located on the side of the engine that is towards the **front** of the vehicle (see Figure 2)
