SERVICE BULLETIN

Classification: EC04-007a	Reference: NTB04-027a	Date: March 24, 2004
------------------------------	--------------------------	-------------------------

2004 MAXIMA AND QUEST (WITH 5 SPEED A/T ONLY); MIL ON WITH DTC P0171 / P0174 / P1273 / P1283 A/F SENSOR / FUEL INJECTION SYSTEM

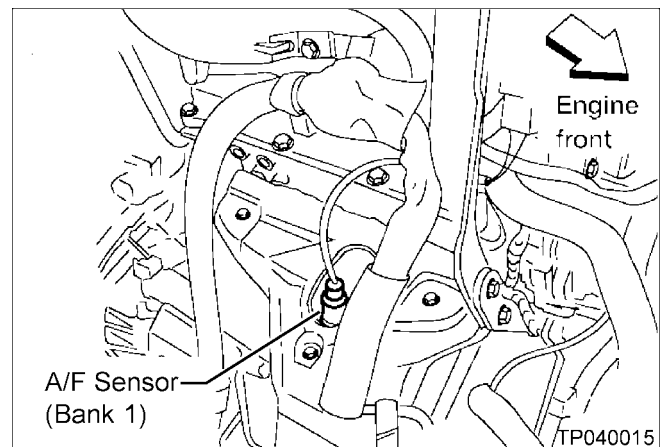
Figure 1

For DTC code(s) P0171 and/or P1273:

- Replace A/F Sensor—Bank 1.
- It's located on the side of the engine that is towards the **rear** of the vehicle (see Figure 1).

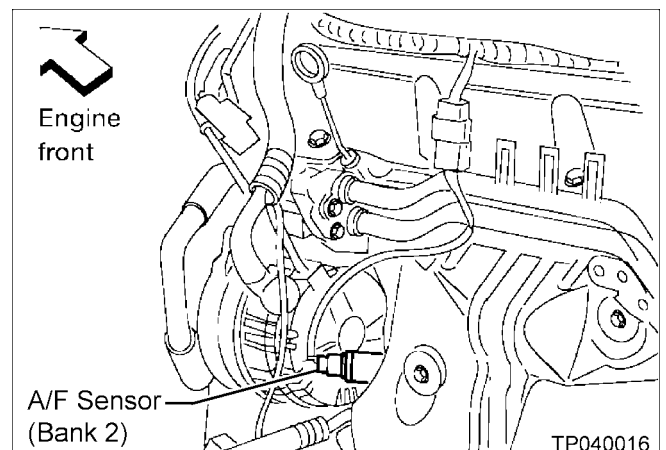
Figure 2

For DTC code(s) P0174 and/or P1283:

- Replace A/F Sensor—Bank 2.
- It's located on the side of the engine that is towards the **front** of the vehicle (see Figure 2).
