## SERVICE BULLETIN

EC04-008a

### 2004 TITAN AND ARMADA; MIL "ON" WITH DTC P1031, P1051, P1148, P1168 A/F SENSOR HEATER / CLOSED LOOP

**APPLIED VEHICLES:** 2004 Titan (A60)  
2004 Armada (TA60)

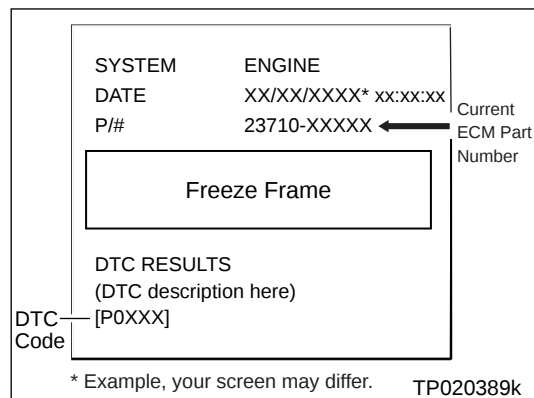
- Figure 1 is an example of the F.F. Data printout.
- The Freeze Frame data that you’ve printed contains the ECM Part Number (P/N).
- The ECM part number will be used to see if this bulletin applies or not.

3. Check the ECM Part Number on the printout from Step 1 (Figure 1);

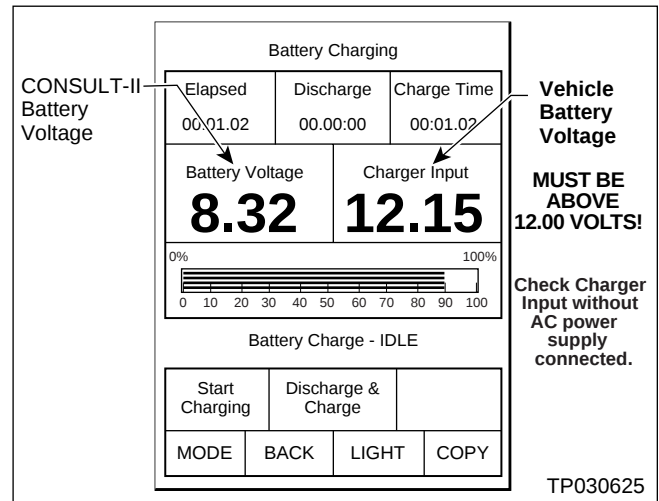
Figure D

- **"Battery Voltage"** is the voltage level of CONSULT-II's battery.
- **"Charger Input"** is the voltage level of the vehicle's battery. **(It must be above 12 volts.)**

3. Check the CONSULT-II's "Charger Input" reading (see Figure D).

**CAUTION:** If the **"Charger Input"** is below 12 volts:
