# SERVICE BULLETIN

EC05-006a

## MIL "ON" WITH DTC P1402 (EGR OPEN) CODE STORED

2004-2005 Maxima (A34 ) and Quest (V42),  
2005 Altima (L31) w/VQ35 Engine

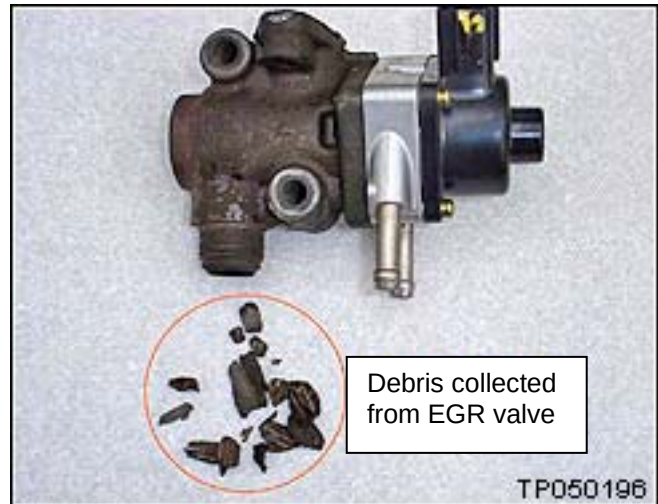
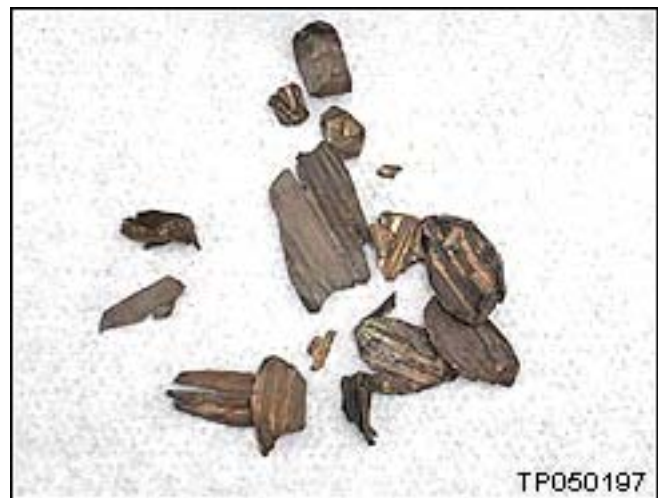
2. Inspect the EGR valve for metallic flake debris. (see Figures 1 and 2)

3. If metallic debris is present in the EGR valve, remove Bank 1 catalyst (rear of engine) as per EM section of the respective ESM.

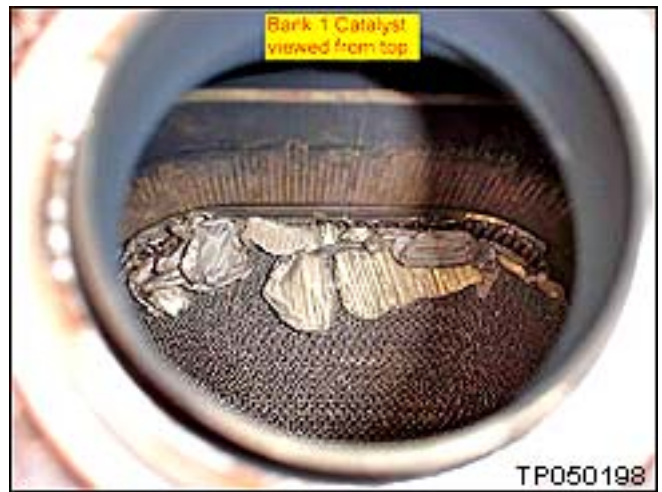
- Bank 1 Catalyst–viewed from the top.  
(see Figure 3)

5. If the catalyst has loose material as seen in Figure 3 above, blow out the debris from interior of Bank 1 exhaust manifold. Remove the EGR valve and tube, and then blow out any debris from the EGR valve and tube.
6. Replace the Bank 1 catalyst and EGR valve in the reverse order of removal.
7. Clear stored code P1402 from the ECM memory.
