SERVICE BULLETIN

Classification: EC05-013	Reference: NTB05-095	Date: October 21, 2005
-----------------------------	-------------------------	---------------------------

RATTLE NOISE FROM B1 CATALYST HEAT SHIELD AND /OR MIL ON WITH DTC P1273

APPLIED VEHICLES: 2004 - 2005 Maxima (A34),
2004 - 2005 Quest (V42)
2004 - 2005 Altima (L31) VQ35 Engine ONLY

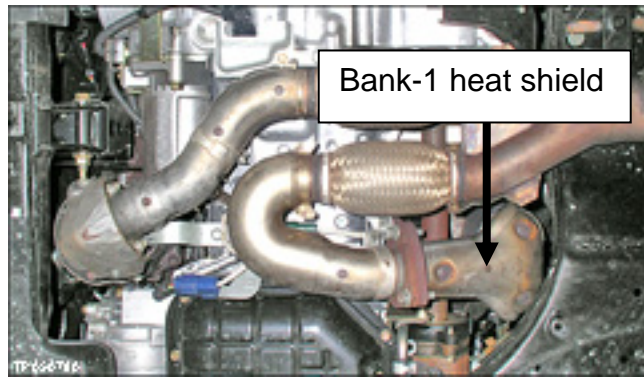
Figure 1

- Inspect for a loose heat shield at the bottom of the Bank -1 catalyst. It may have "separated".
- If heat shield is loose replace the catalyst.

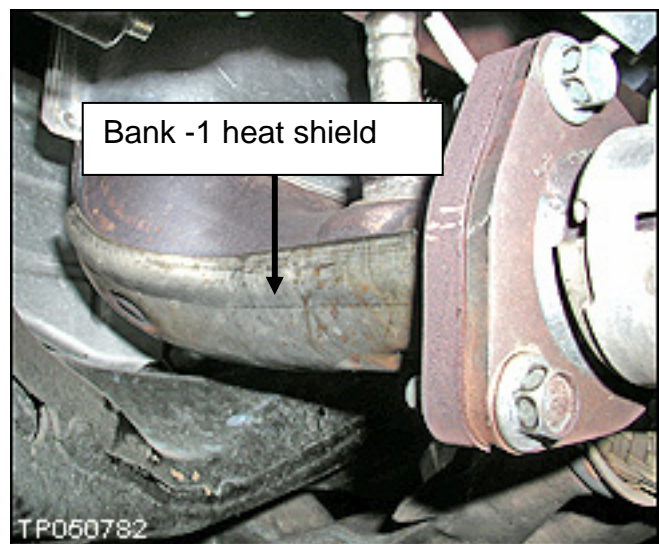
Figure 2

1. Put the vehicle on a hoist.
2. Inspect the Bank-1 catalyst heat shield for looseness by attempting to move heat shield by hand see Figure 2.

4. If the heat shield is loose so it can be moved by hand or any of the 3 heat shield welds are separated, replace the catalyst.
5. If the incident included DTC P1273, after replacing the catalyst, you must also complete the following steps:
 1. Erase the DTC.
 2. Clear self learning using CONSULT WORK SUPPORT mode. Select SELF LEARNING CONT then START followed by CLEAR.

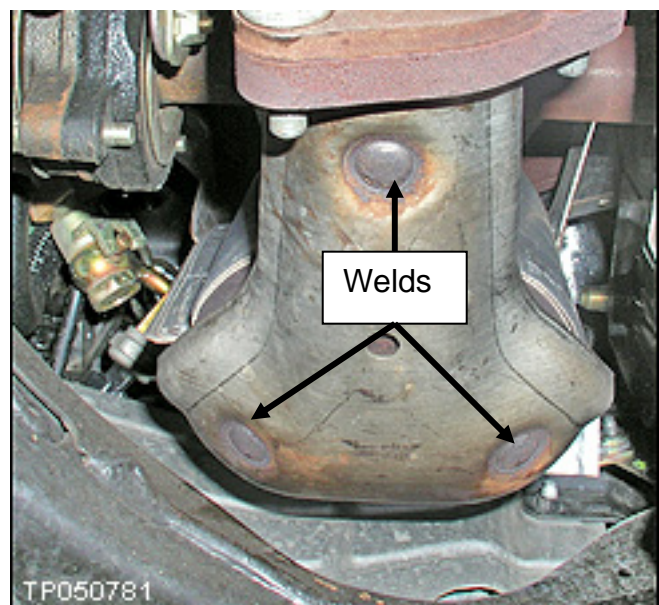
Figure 3

3. Inspect the Bank-1 heat shield welds for separation see Figure 3.
