## SERVICE BULLETIN

EC08-018

### 2004 – 2009 TITAN AND ARMADA; DTC P0335

**APPLIED VEHICLES:** 2004 – 2009 Titan (A60)

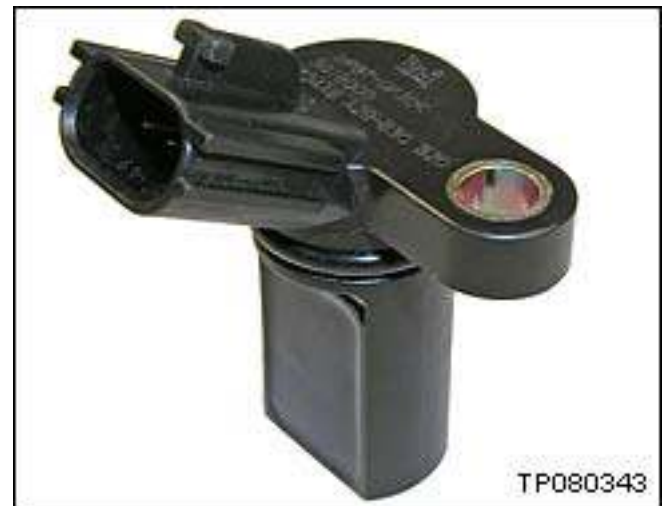
Figure 1

- The **Crankshaft** Position Sensor and **Camshaft** Position Sensor look identical (see Figure 1).
- When servicing / repairing the vehicle, or during a previous repair, it's possible to install these sensors in the wrong locations:
  - Locations swapped, or
  - Two of the same sensor installed

Make sure the **Crankshaft** Position Sensor and the **Camshaft** Position Sensor are installed in the correct locations.

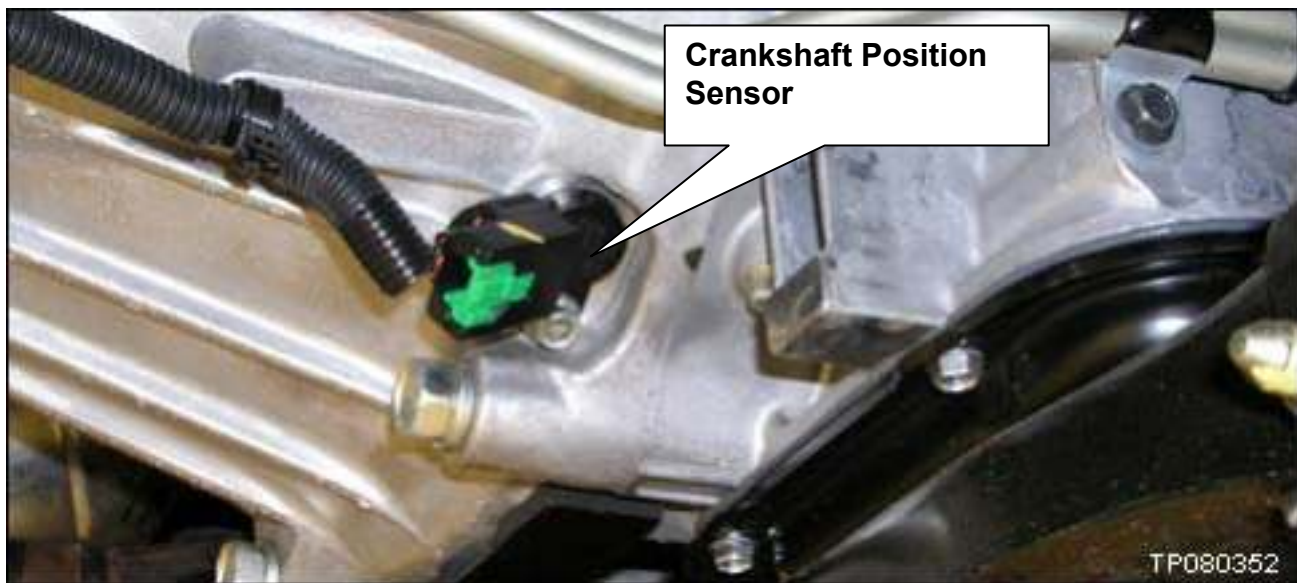
Figure 2

- The **Crankshaft** Position Sensor is located at the lower front of the transmission.

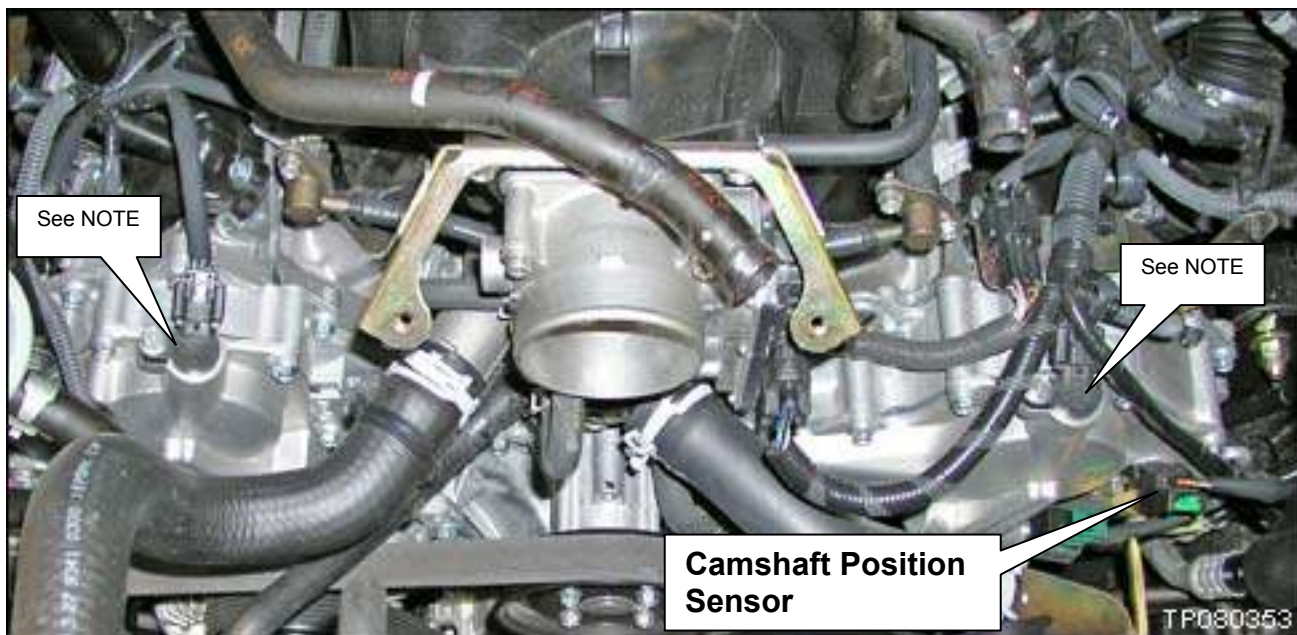
- The **Camshaft** Position Sensor is located at the front of the driver side cylinder head (Bank 1).

**NOTE:** 2007 to 2009 Applied Vehicles are equipped with Intake Valve Timing Control Position Sensors (Bank 1 and Bank 2). These sensors are identical to the Camshaft Position Sensor. All three sensors shown in Figure 3 use the same Nissan Part Number.

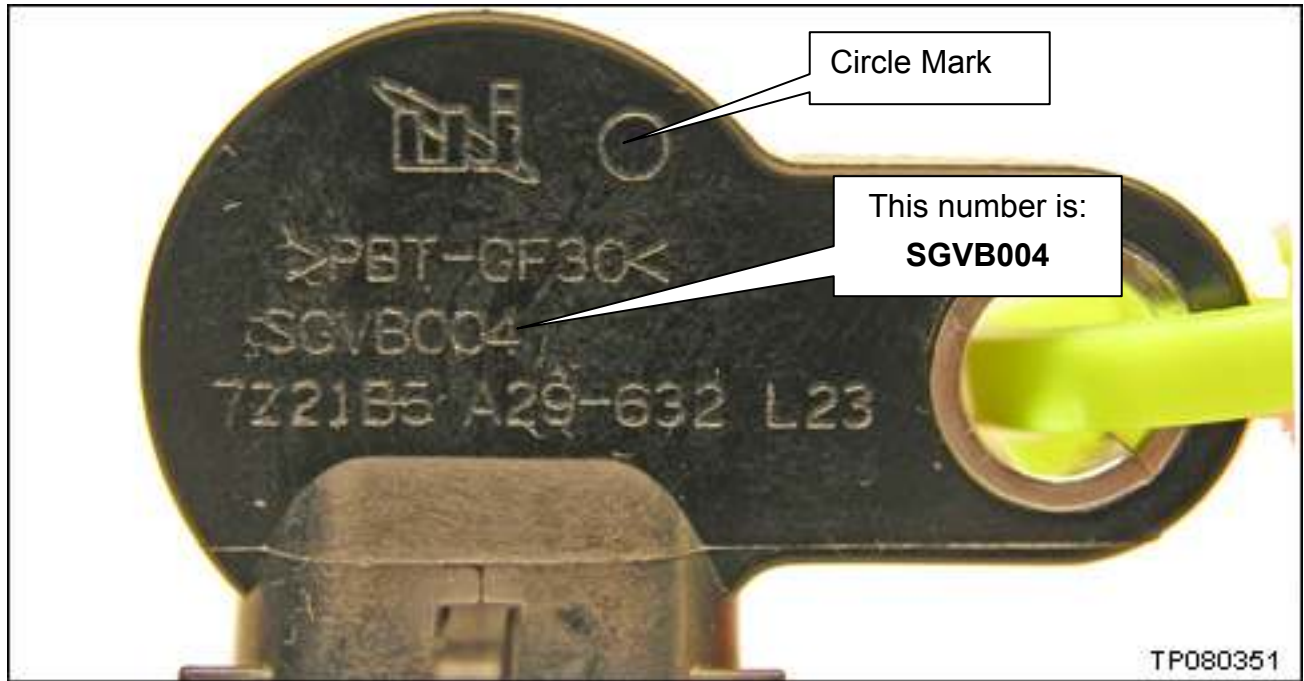
Figure 4

### Crankshaft Position Sensor

- Refer to the Nissan parts system (FAST or equivalent) to get the appropriate sensor Part Number for the model year vehicle you are working on.
- To identify a Crankshaft or Camshaft position sensor that has been removed from its package, compare the sensor to Figures 4 and 5.

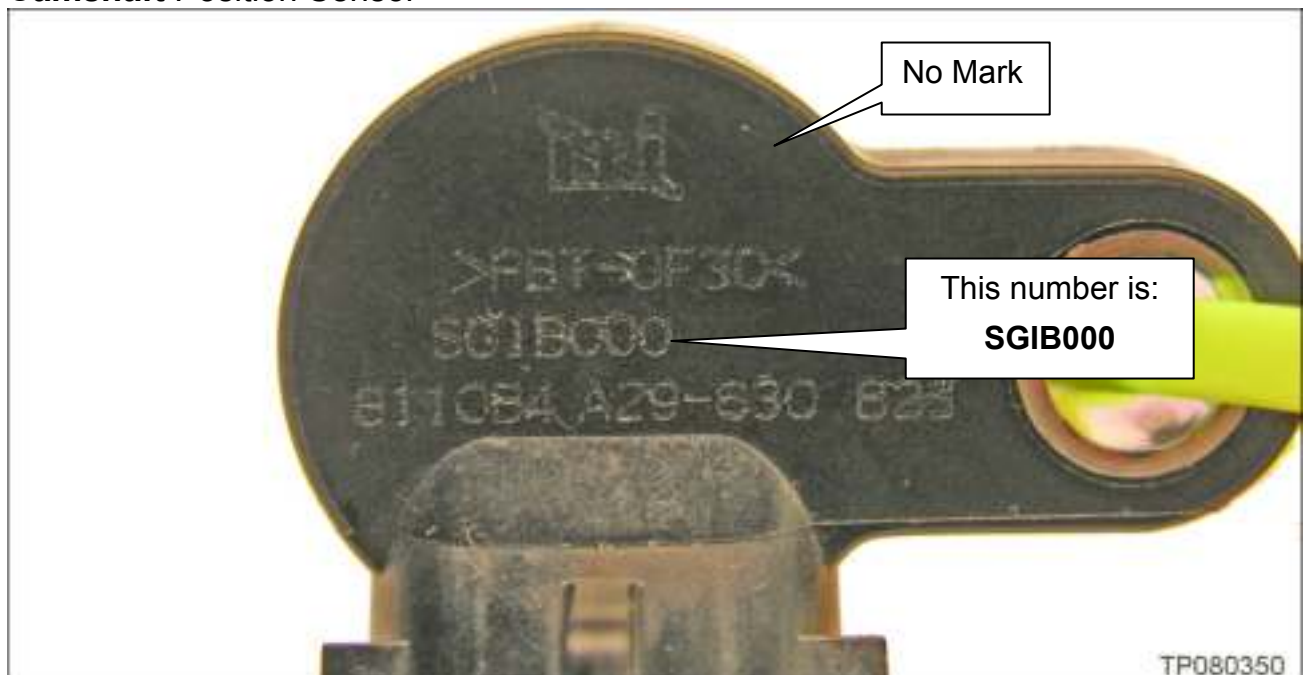
Figure 5

### Camshaft Position Sensor
