# SERVICE BULLETIN

EC09-024

October 23, 2009

## 2007 – 2009 VERSA; DTC P1421 STORED

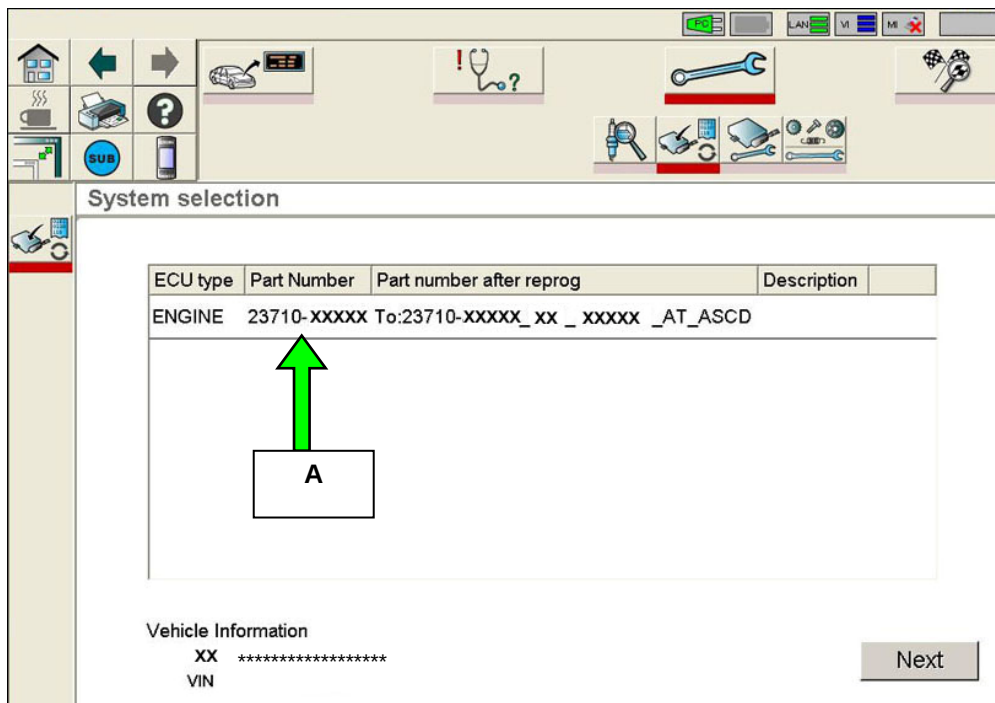
Figure 1

3. When you get to the ECM Reprogramming screen shown in Figure 1, confirm this bulletin applies as follows.

A. On your C-III screen, look at the **Part Number** column (see Figure 1):

- If this column is **blank** (no part number listed), this **bulletin does not apply**. Close C-III and refer to ASIST for further diagnostic information.
- If a Part Number is listed, write it on the Repair Order.

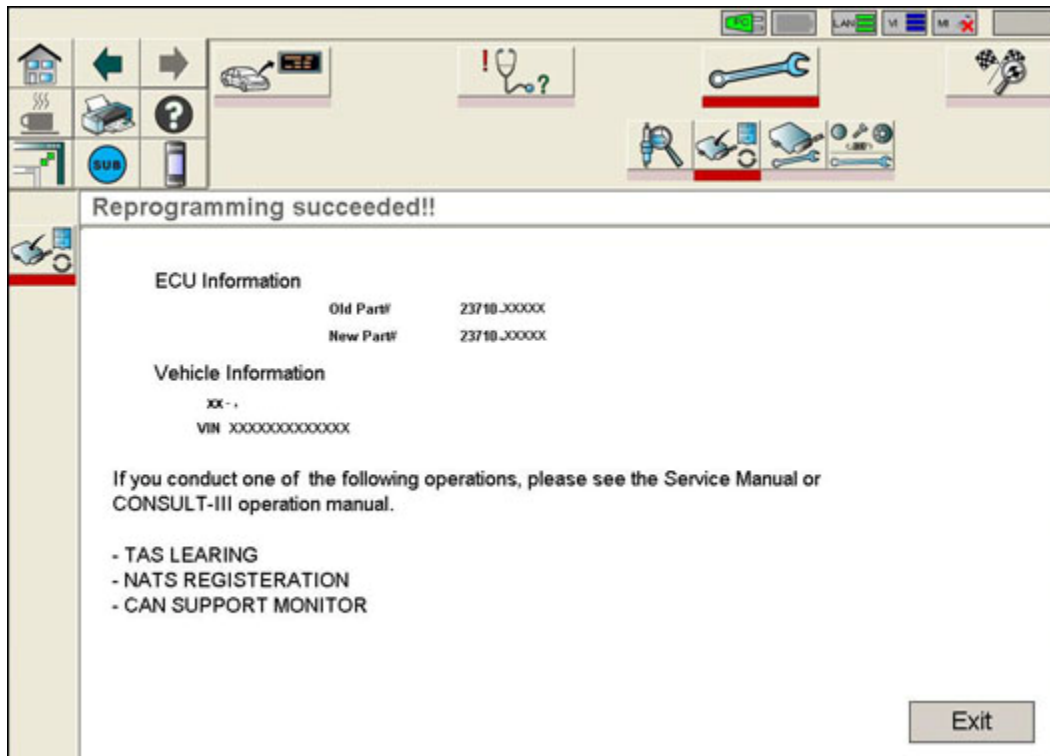
4. If this bulletin applies and you have performed ECM reprogramming, the screen in Figure 2 appears when reprogramming is complete.

**Print this screen and attach it to the Repair Order for Warranty documentation.**
