## SERVICE BULLETIN

EC10-023

### 2009 – 2010 cube<sup>®</sup> MIL 'ON' WITH DTC P1421 STORED

**APPLIED VEHICLE:** 2009 – 2010 cube<sup>®</sup> (Z12)

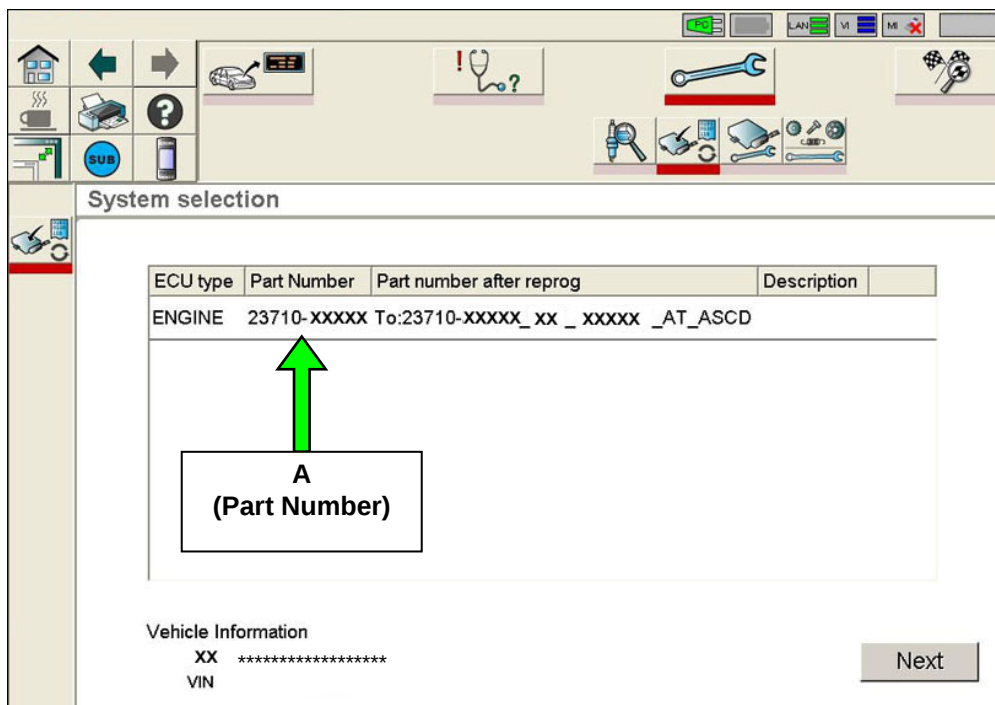
Figure 1

2. When you get to the ECM Reprogramming screen shown in Figure 1, confirm this bulletin applies as follows.

A. On your C-III screen, look at the **Part Number** column (see Figure 1):

- If this column is **blank** (no part number listed), this **bulletin does not apply**. Close C-III and refer to ASIST for further diagnostic information.
- If a Part Number is listed, write it on the Repair Order.

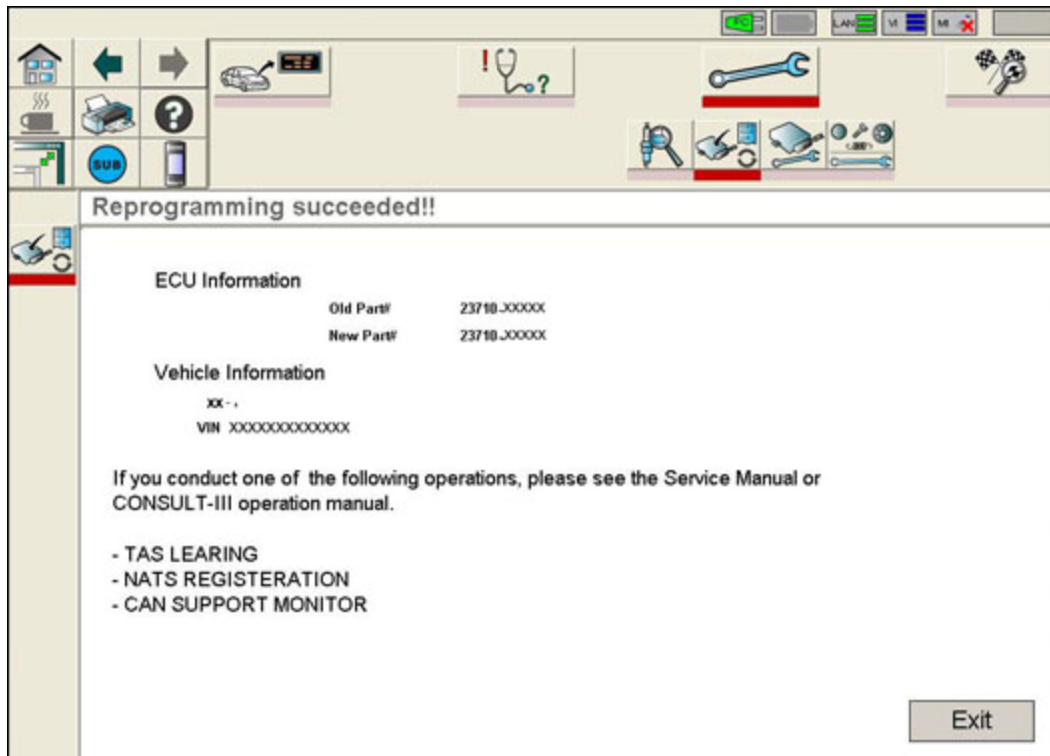
3. If this bulletin applies and you have performed ECM reprogramming, the screen in Figure 2 appears when reprogramming is complete.

**NOTE:** If the screen in Figure 2 does not display (reprogramming does not complete), [click here](#). This links to the ECM Reprogram Interruption Recovery General Procedure.

- **Print this screen and attach it to the Repair Order for Warranty documentation.**
