# SERVICE BULLETIN

EC97-050a

August 1, 1998

## DIAGNOSTIC PROCEDURE FOR DTCs P0120, P0510, P0731, P0732 OR P0733 WITH NO DRIVEABILITY INCIDENTS

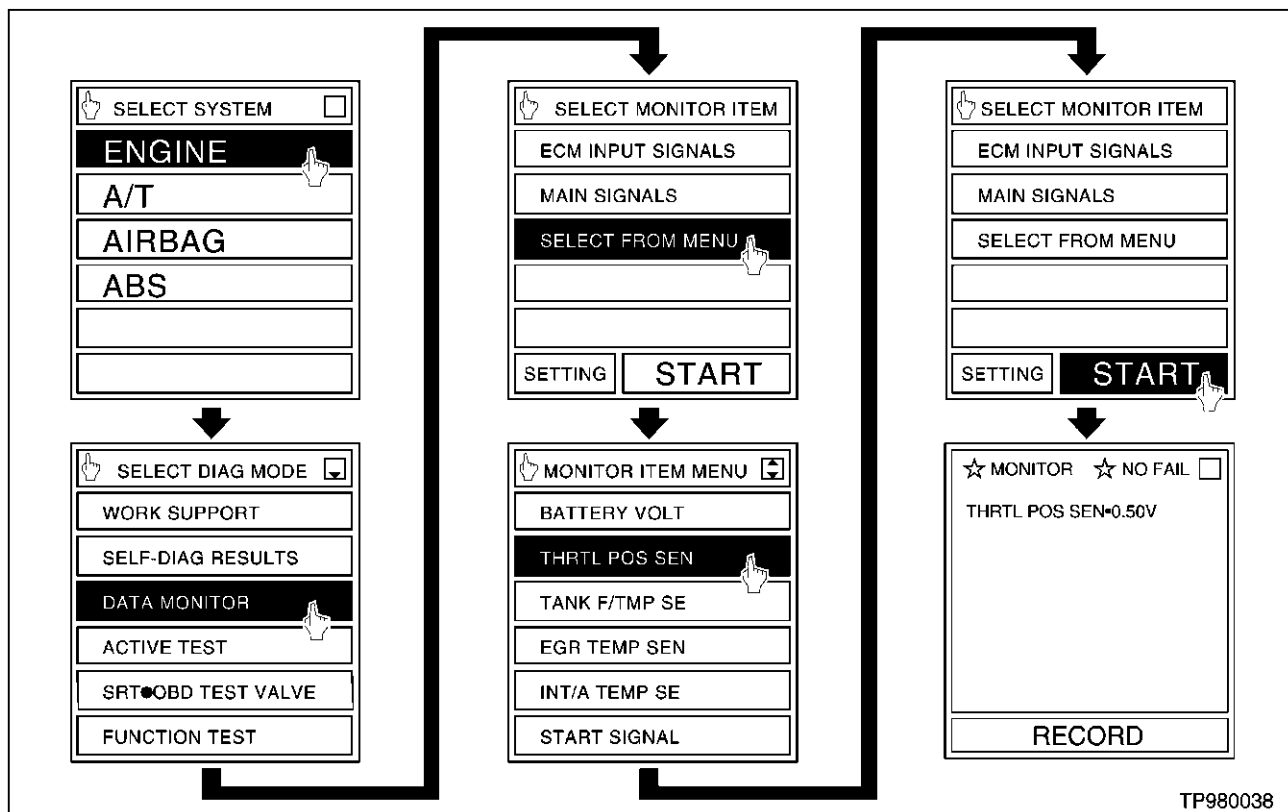
Figure 1

1. Start the vehicle and warm up the engine (coolant temperature above 160°F).
2. Shut the engine off. Then turn the key to the ON position.
3. Using CONSULT, select THRTL POS SEN in the Data Monitor mode (see Figure 1, page 2).
4. Note the TPS voltage (initial resting voltage).
5. Depress the accelerator fully and then release slowly until it releases completely.
6. Wait 5 seconds and monitor the TPS voltage again (final resting voltage). Note any change.

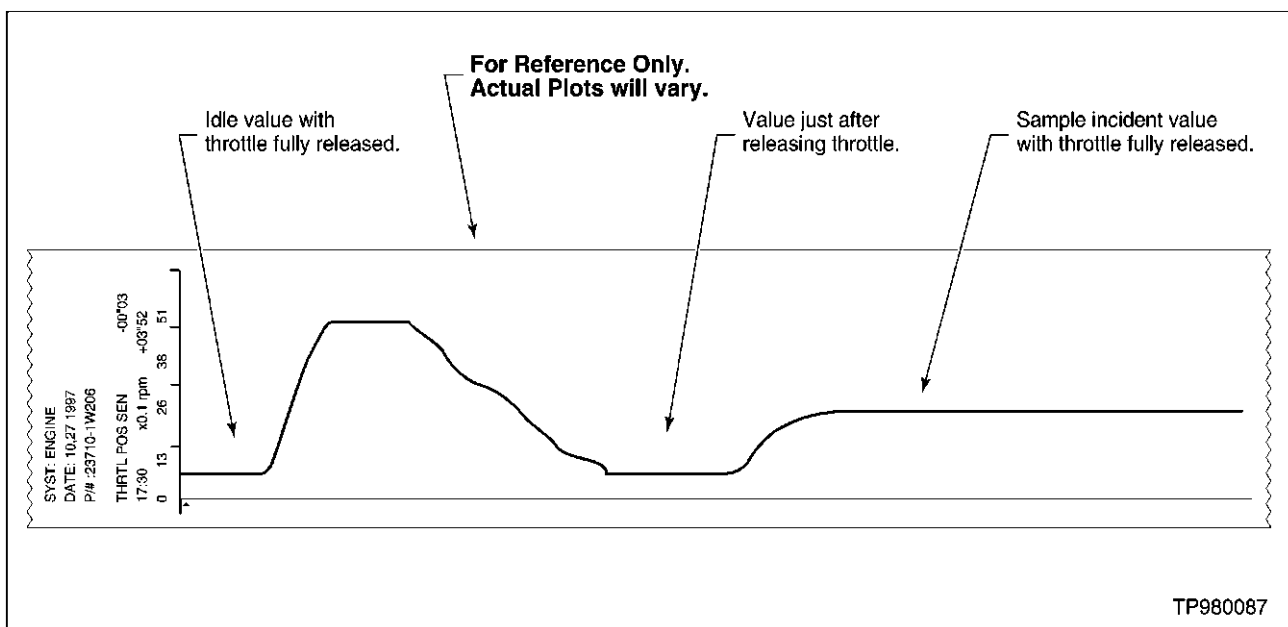
**NOTE:** Figure 2 is a visual representation of the incident and is **for reference only**. It will be easier to perform this test based on the actual voltage values displayed (as in the last frame of Figure 1) rather than to graph the voltage output. *Use the actual voltage values to monitor the voltage change.*
