# M.I.L. "ON" DTC P2714 with Transmission Performance DTCs

Some customers may complain about a M.I.L. "ON" condition with DTC P2714 (Pressure Control Solenoid "D" Performance – Shift Solenoid SLT) combined with other transmission performance DTCs such as P0751, P0756, P0761, P0766, P0729, P0781, P0894, P2757, or P0776 with abnormal transmission shifting. Replacement of the transmission and installation of revised Engine Control Module/ECM (SAE term: Powertrain Control Module/PCM) software logic may be required to repair the vehicle. Follow the repair procedure below to address customer concerns.

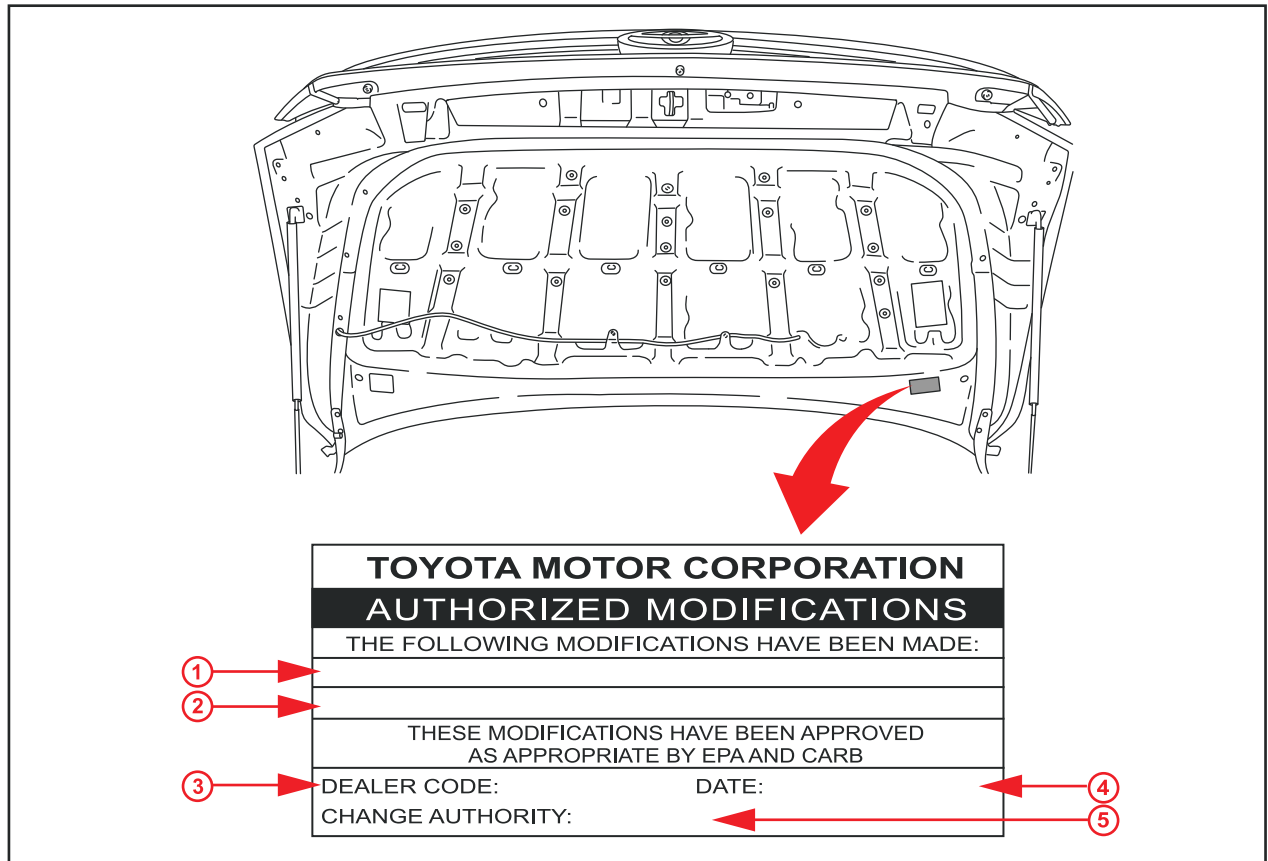
Figure 1. Location of Authorized Modifications Label on 2008 Tundra

7. Check for the Authorized Modifications Label affixed to the vehicle in the location shown in Figure 1. Confirm if the ECM (PCM) calibration has been updated. If the calibration ID listed is NOT the latest ECM (PCM) calibration — go to step 8.

9. Start the engine and warm it up to normal operating temperature before test driving.
10. Test drive the vehicle to confirm proper vehicle operation.
11. Install the Authorized Modifications Label.
  - A. Using a permanent marker, enter the following information on the label:
    - ECM part number [Refer to the **Parts Information** section for the **CURRENT PART NUMBER**]
    - Calibration ID(s) [Refer to the **Calibration Identification Chart** for the **NEW CALIBRATION ID**]
    - Dealer Code
    - Repair Date
    - Change Authority [**This TSB number**]
  - B. Affix the Authorized Modifications Label to the vehicle at the location shown in Figure 1. The Authorized Modifications Label is available through the MDC, P/N 00451-00001-LBL.
