# Technical Bulletin

**15 09 03** Dec. 16, 2009 **2015153** Supersedes T. B. Group 15 number 09-02 dated November 10, 2009 to revise technical diagnosis code in warranty table.

### **MIL ON, DTC P0087, P1093 or P2293 Stored in ECM Fault Memory**

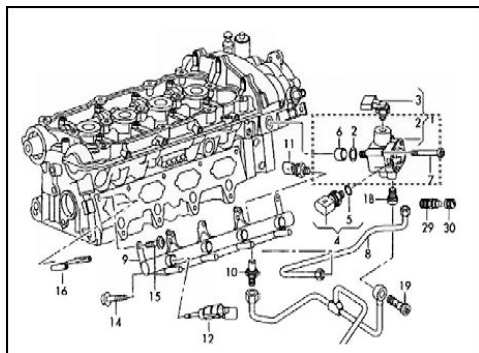
Remove the high pressure fuel pump and visually inspect:

1. Base surface of the cam follower -6- in contact with the camshaft lobe.
2. Tip of the high pressure fuel pump plunger.
3. High pressure fuel pump camshaft lobe.

If the base of the cam shaft follower looks like -C- or -D-, **no excessive wear is present**.

If the cam follower base surface is excessively worn so that its surface is concave -B- or missing -A-, inspect the intake cam shaft lobe for wear.

Cam follower and camshaft should **NOT** be replaced.

If the high pressure fuel pump camshaft lobe shows excessive wear, replace the intake camshaft with Part No. 06F109101B and the cam follower with Part No. 06D109309C, see Group 15 Engine - Cylinder head, Valvetrain in ElsaWeb.

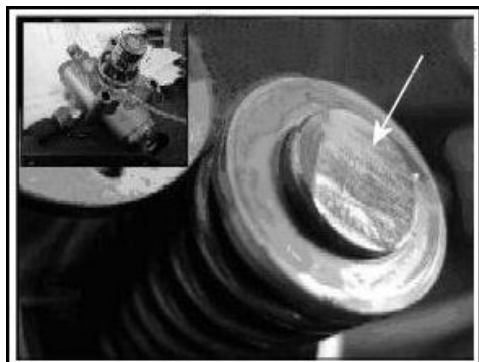
Inspect the tip of the high pressure fuel pump plunger for excessive wear.

High pressure fuel pump plunger damage is only possible if the cam follower base has a hole in it and the plunger tip has come in direct contact with the camshaft lobe.

If plunger tip of fuel pump is **NOT WORN**, **DO NOT REPLACE** the fuel pump.

If excessive wear is found the high pressure pump must also be replaced, see Group 20 Fuel Supply in ElsaWeb.
