SERVICE BULLETIN

Classification: EC06-001a	Reference: NTB06-009a	Date: March 31, 2006
------------------------------	--------------------------	-------------------------

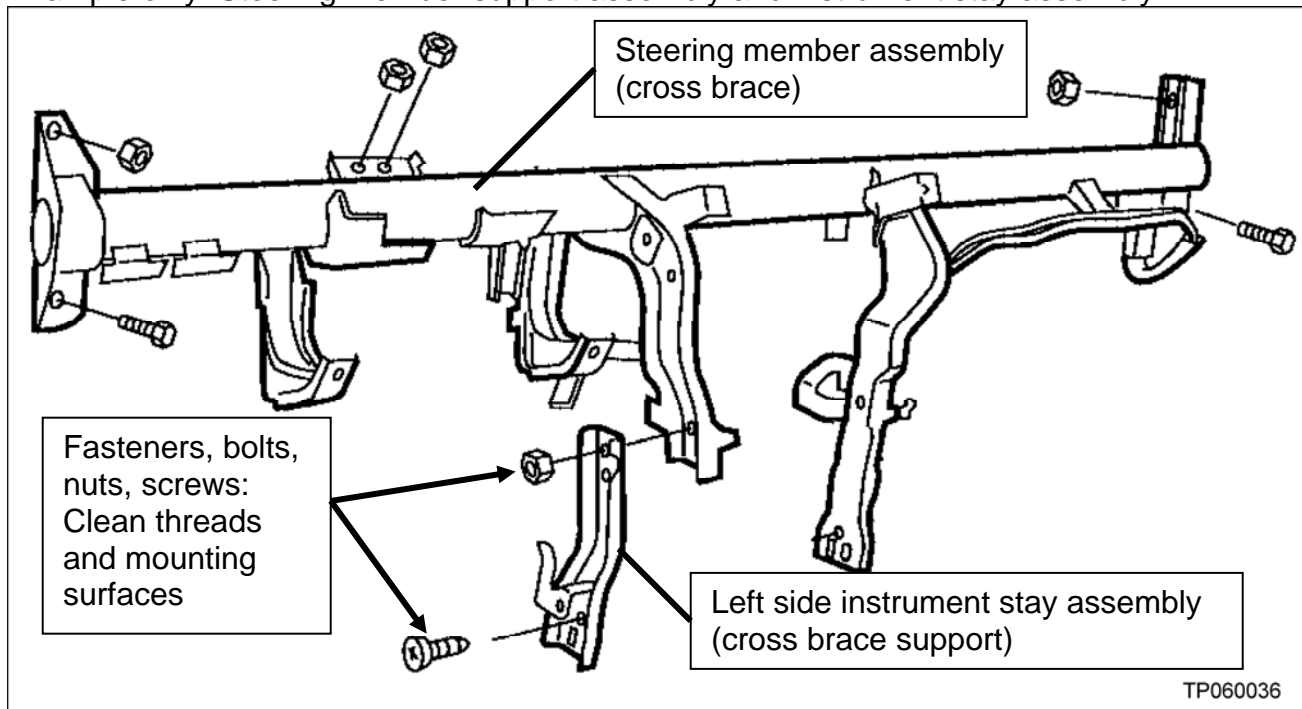
Example only: Steering member support assembly and instrument stay assembly
