## SERVICE BULLETIN

EC09-030

### 2008 – 2010 ROGUE; DTC P0444 STORED

**APPLIED VEHICLES:** 2008 – 2010 Rogue (S35)

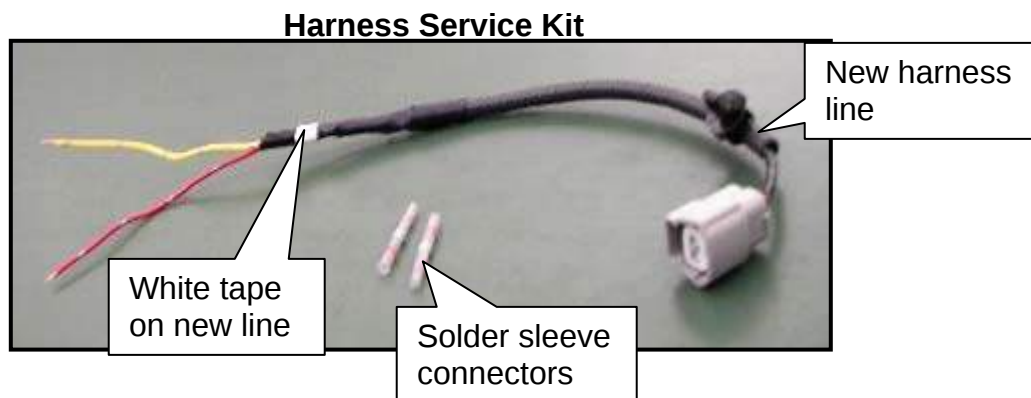
| DESCRIPTION | P/N | QUANTITY |
|---|---|---|
| Harness Service Kit (Harness-Sub) | 24028 - CZ30A | 1 |

- Fold the wires of the new line along the EGI harness so the white tape on the new line is next to (touching) the EGI harness.
- Make sure the white tape on the new line is covered. (Refer to the Harness Repair Kit photo in the Parts Information).

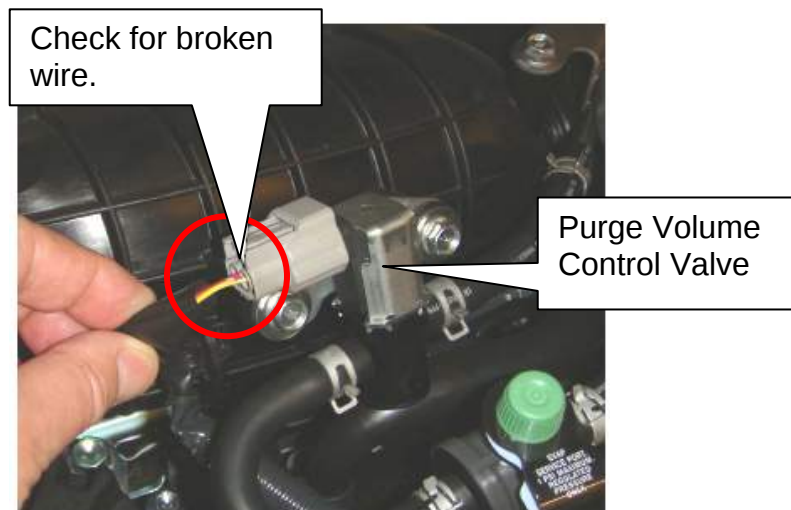
1. Inspect the wires at the back of the Purge Volume Control Valve connector.
  - Check for a broken wire inside the plastic sheath. If a wire is broken inside the plastic sheath, the plastic sheath will stretch when pulled.

- Wire is broken: Go to [Install Harness Service Kit](#) on the next page.
- Wire is not broken: This bulletin does not apply. Refer to ASIST for further diagnostic and repair information.

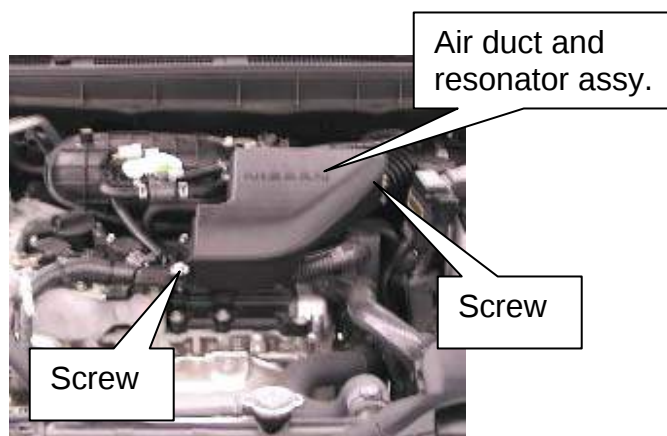
3. Remove the air duct and resonator assembly.

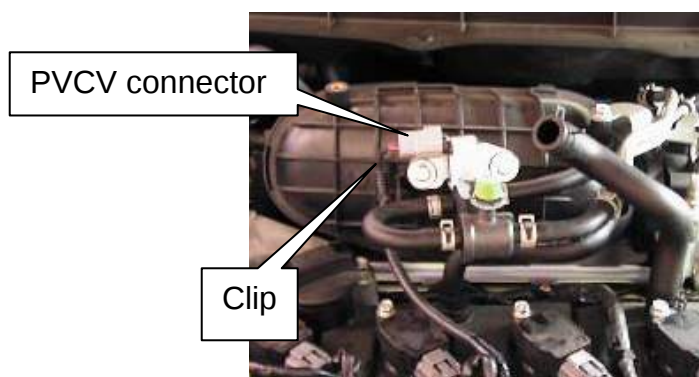
4. Disconnect the Purge Volume Control Valve (PVCV) connector and clip.

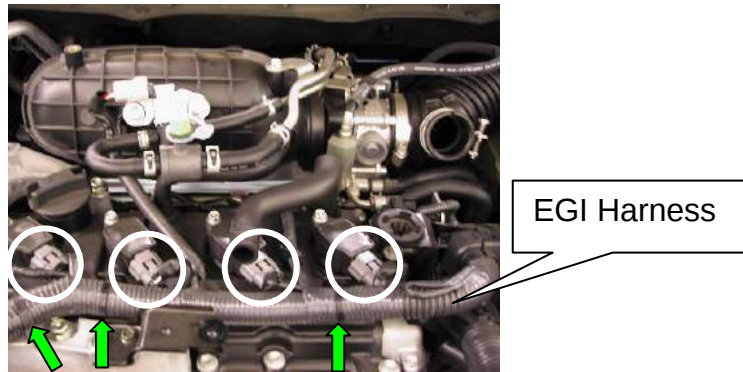
5. Disconnect the 3 clips and 4 connectors shown.

↑ = Clip      ○ = Connector

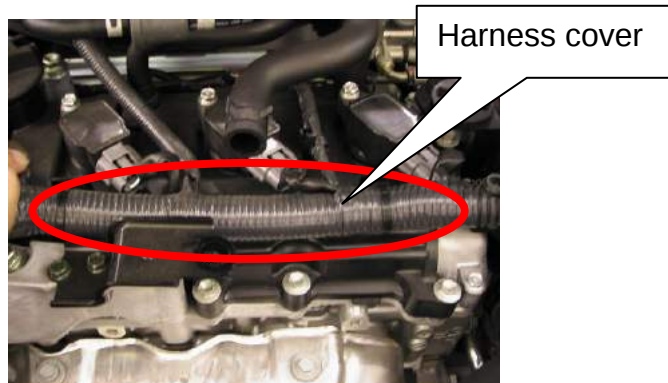
6. Remove tape from the harness cover in the area shown.

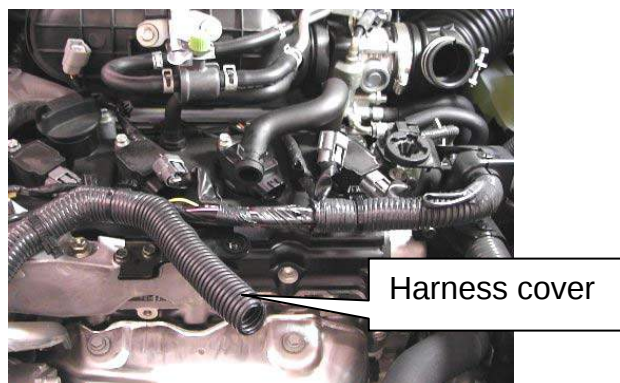
7. Carefully open the harness cover and pull it away from the EGI harness as shown.

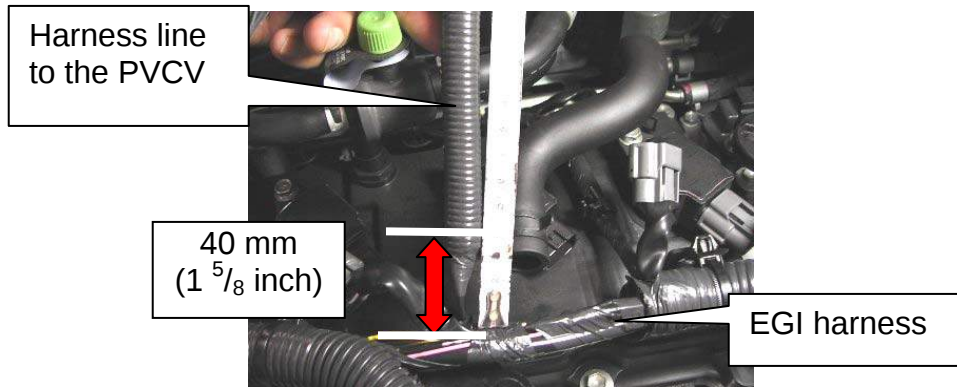
8. Carefully cut the harness line to the Purge Volume Control Valve (PVCV).

- Cut the harness 40 mm ( $1\frac{5}{8}$  inch) from the EGI harness.
- Be careful not to cut it too short.

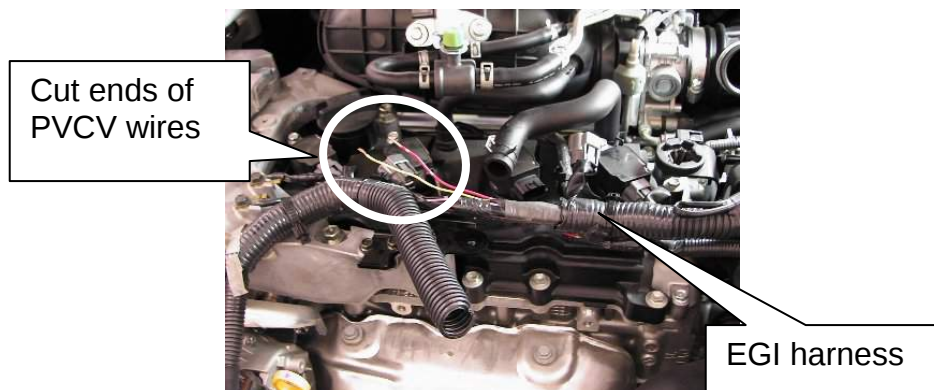
9. Remove any tape from the cut ends of the PVCV wires (Red and Yellow wires).

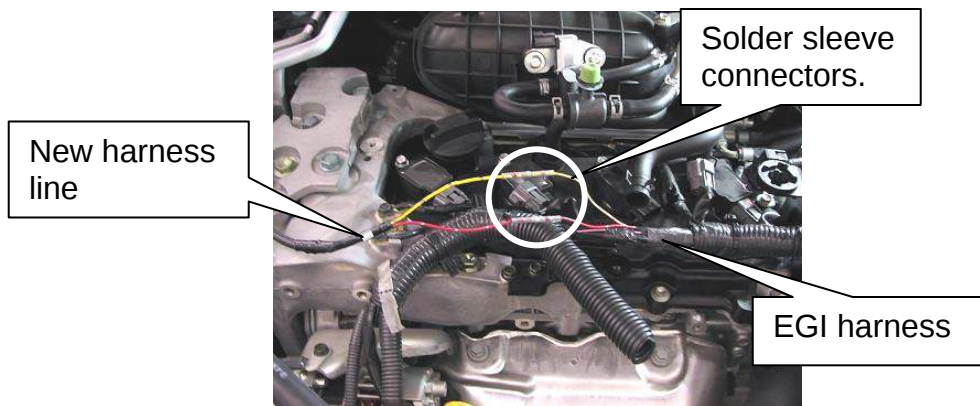
10. Connect the new harness line to the EGI harness with the solder sleeve connectors.

- The new harness line and solder sleeve connectors are included in the Harness Service Kit.
- **Make sure to match the wire colors (Red<=>Red, Yellow<=>Yellow).**
- If needed, refer to NTB03-078 for information on using / installing solder sleeve connectors.

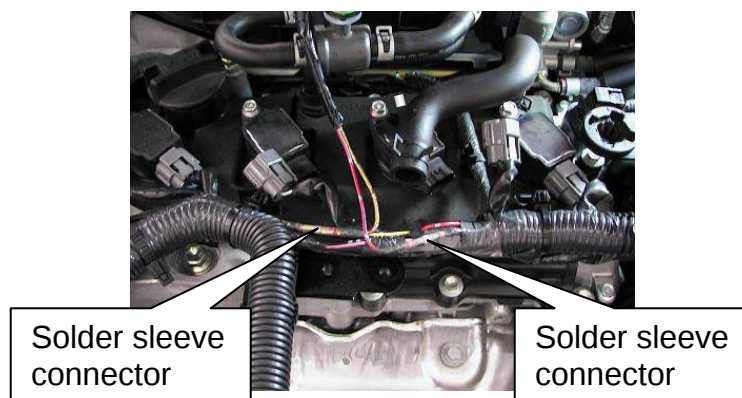
11. Separate the solder sleeve connectors and place them on the EGI harness as shown.

- **Make sure to prevent overlap of the solder sleeve connectors, they should not touch each other.**

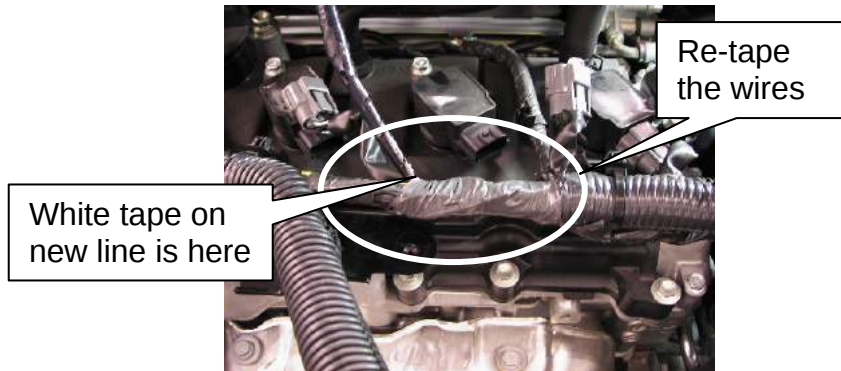
12. Carefully re-tape the wires as shown.

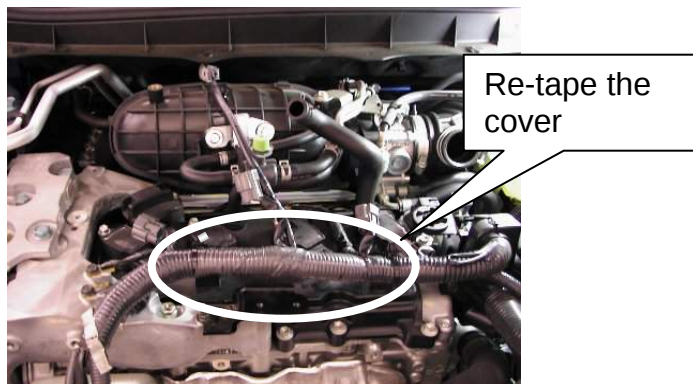
13. Carefully reinstall the harness cover and then re-tape the harness cover as shown.

- Make sure all wires are inside the harness cover.

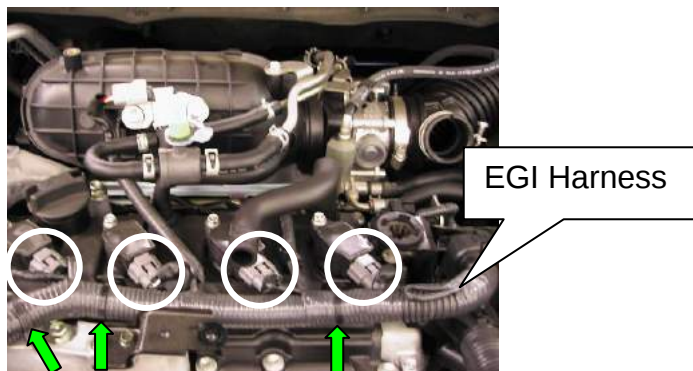
14. Re-connect the clips and connectors.

↑ = Clip      ○ = Connector

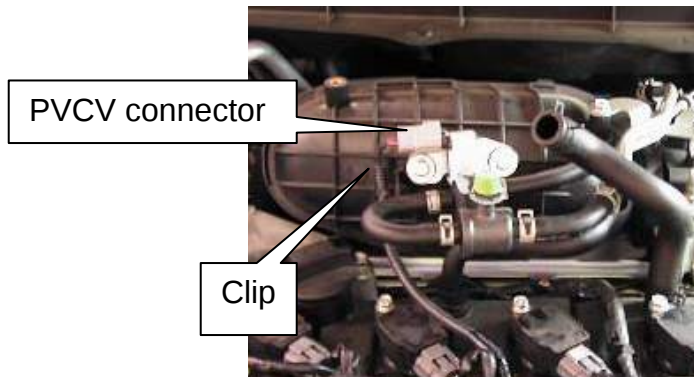
15. Re-connect the Purge Volume Control Valve connector and clip.

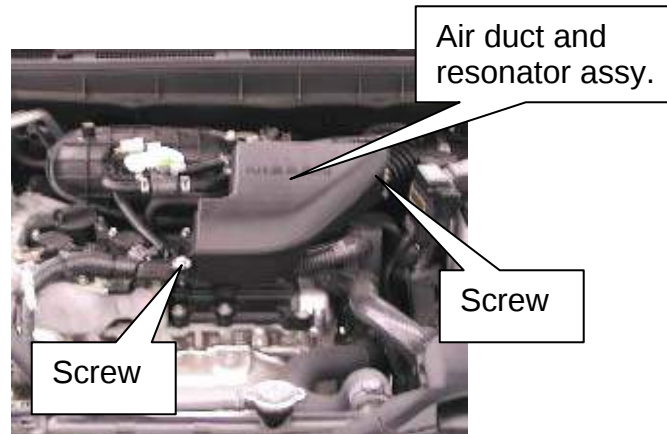
16. Reinstall the air duct and resonator assembly.
