# Service Bulletin

Bulletin No.: 16-NA-383

**Subject:** Information on Rough Idle, Crank No Start, Extended Crank or Misfire Due to Excessive Carbon on Top of Valves or Sticking Valves, Malfunction Indicator Light (MIL) Illuminated - DTC P0300, P0301, P0302, P0303, P0304, P0305, P0306, P0307, P0308 Set

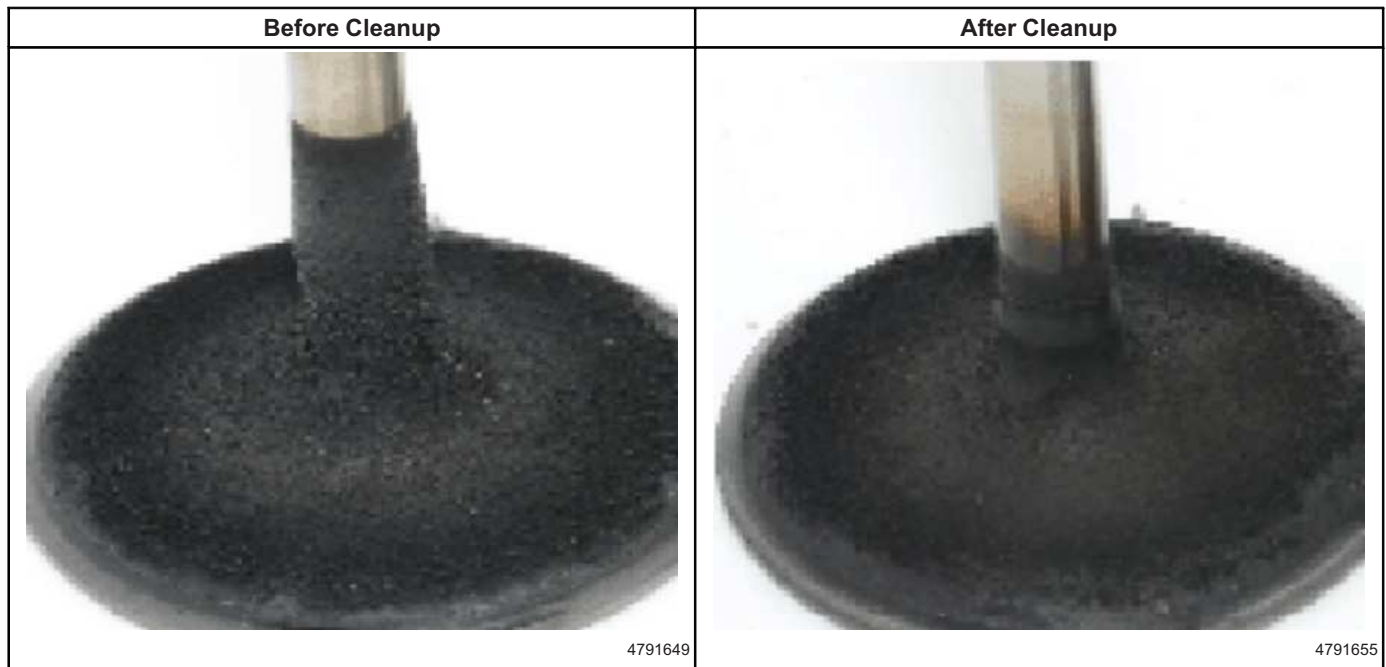
- If there is no sign of valve damage or cam followers that are out of place, perform the following procedure to free up sticking valves and to remove carbon from the valves and pistons.
- If valve damage is present or if there are cam followers that are out of place, perform engine mechanical repairs as necessary to correct the concern and then perform the procedure below to prevent the concern from returning.
- Perform an upper engine and valve cleaning procedure.
- Below are examples of valves that have gone through a Top Engine cleaning procedure.
