## PIP5495G Check Engine Light On With P0299 Or P0234

| Cause: | Misdiagnosis Leading to Returned Turbochargers with NTF |

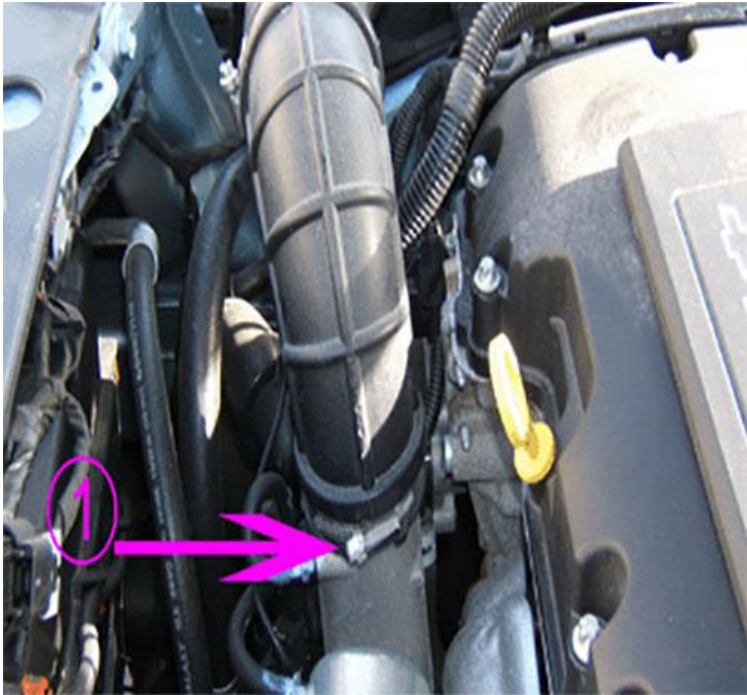
Notice: The view shown below indicates **NORMAL** oil staining in the turbocharger outside air inlet. This dry stain does not represent an oil leak.

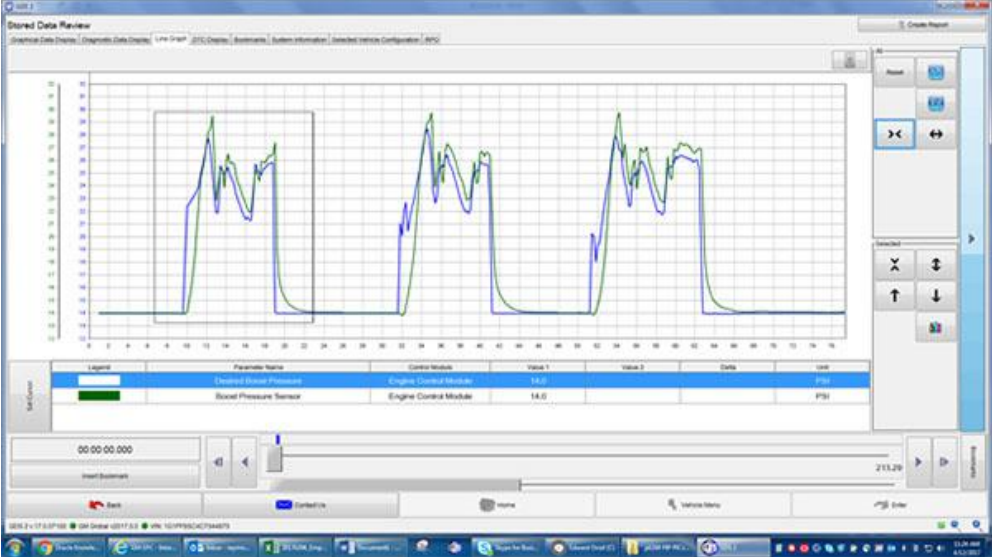
Example of normal turbocharger wastegate operation:  
In this example, notice that the measure window begins once the Boost Pressure Sensor reading (Green) meets the Desired Boost Pressure reading (Blue) and ends when the APP is released per the testing instructions.  
The Boost Pressure Sensor reading (Green) closely tracks the Desired Boost Pressure reading (Blue) indicating normal Turbocharger

operation.
