SERVICE BULLETIN

Classification: EC04-001	Reference: NTB04-025	Date: February 19, 2004
-----------------------------	-------------------------	----------------------------

2004 MAXIMA AND QUEST (4AT & 6MT MODELS ONLY); MIL ON P0171 / P0174 / P1273 / P1283

APPLIED VEHICLE: 2004 Maxima (A34) with 4-speed A/T and 6-speed M/T
2004 Quest (V42) with 4-speed A/T

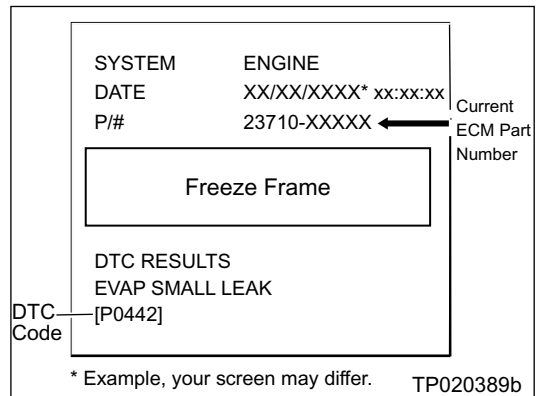
- The Freeze Frame data that you’ve printed contains the ECM Part Number (P/N).
- Figure 3 is an example of the F.F. Data printout.

Compare the Current ECM Part Number to Chart A:

Compare the vehicle's current ECM P/N to those shown under **Current ECM P/N** in **Chart A**, below:

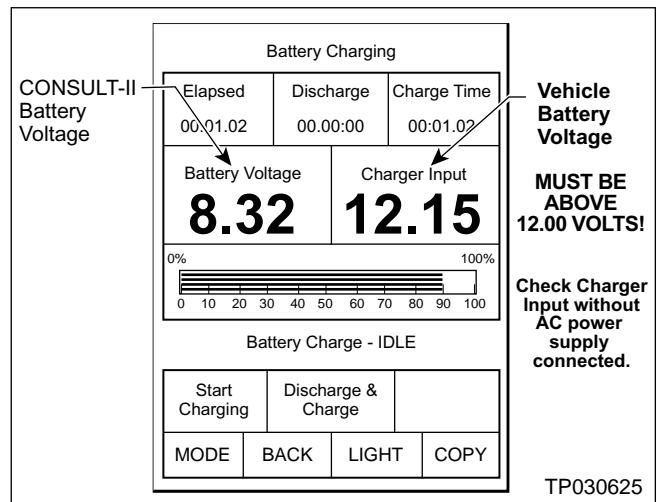
Figure C

- "Battery Voltage" is the voltage level of CONSULT-II's battery.
- "Charger Input" is the voltage level of the vehicle's battery. **(It must be above 12 volts.)**

3. Check the CONSULT-II's "Charger Input" reading (see Figure C).

CAUTION: If the "Charger Input" is below 12 volts:

- Click [here](#) to link to the "ECM Reprogramming For Nissan Vehicles" general procedure, or refer to Attachment A in the print copy of this bulletin.
- The general procedure includes a list of items to check when "Charger Input" voltage is below 12V.
