SERVICE BULLETIN

Classification: EC04-007a	Reference: NTB04-027a	Date: March 24, 2004
------------------------------	--------------------------	-------------------------

2004 MAXIMA AND QUEST (WITH 5 SPEED A/T ONLY); MIL ON WITH DTC P0171 / P0174 / P1273 / P1283 A/F SENSOR / FUEL INJECTION SYSTEM

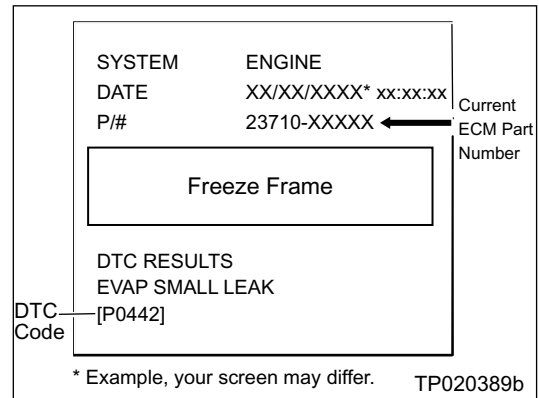
- Figure 3 is an example of the F.F. Data printout.
- The Freeze Frame data that you've printed contains the ECM Part Number (P/N).
- You'll use this ECM P/N to see if reprogramming is needed.

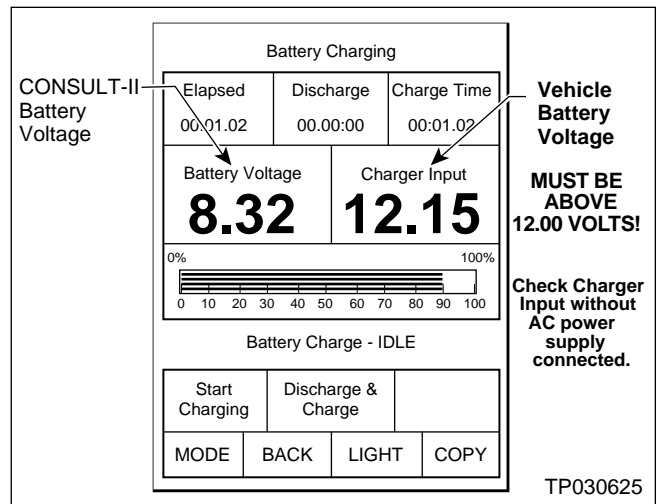
Figure D

- **"Battery Voltage"** is the voltage level of CONSULT-II's battery.
- **"Charger Input"** is the voltage level of the vehicle's battery. **(It must be above 12 volts.)**

3. Check the CONSULT-II's "Charger Input" reading (see Figure D).
