## Technical Service Information Bulletin

**M.I.L. "ON" DTC P0031, P0051, P2238,  
AND/OR P2241**

**'04 – '05 ES 330**

ENGINE  
EG003-05

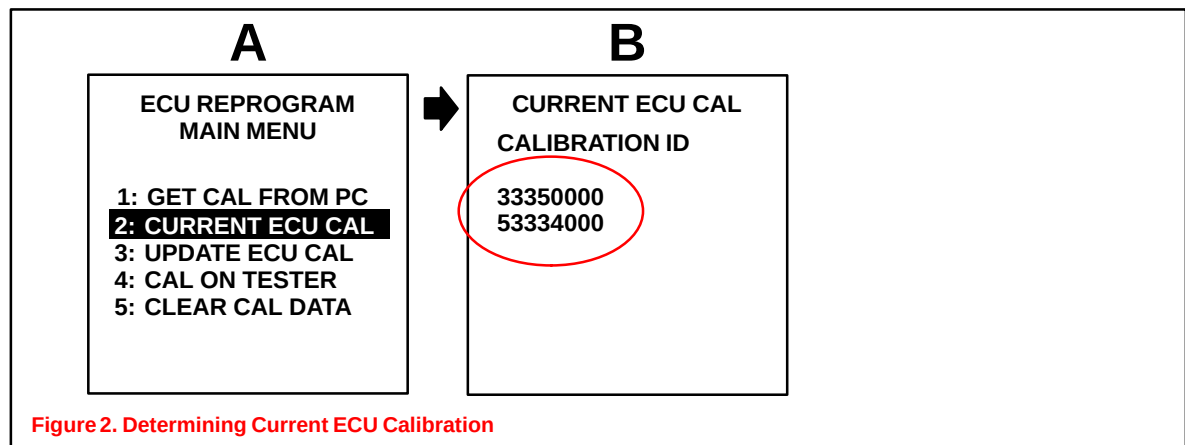
3. Connect the Diagnostic Tester to the vehicle and select CURRENT ECU CAL from the ECU REPROGRAM MAIN MENU. Determine the vehicle's current ECU calibration (see Figure 2).
  - The sample screen prints seen below are the 12.01a software version and may differ from subsequent software versions.
