# SERVICE BULLETIN

EC11-032

## 2011 - 2012 SENTRA WITH MR20DE ENGINE; MIL ON WITH DTC P015B STORED

**APPLIED VEHICLE:** 2011 - 2012 Sentra (B16)**APPLIED ENGINE:** MR20DE (4-cyl) with California Emissions ONLY

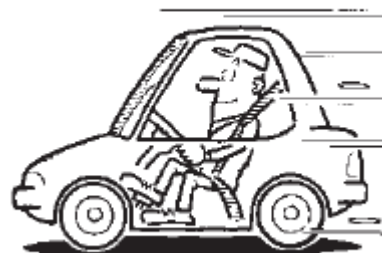
Figure A

- Most instructions for reprogramming with CONSULT-III plus (C-III plus) are displayed on the CONSULT PC screen.
- If you are not familiar with the reprogramming procedure, click here. This will link you to the "CONSULT- III plus (C-III plus) ECM Reprogramming" general procedure.
- Take the vehicle for a 10 minute drive in order to meet the following Idle Air Volume Learn (IAVL) conditions:
  - Engine coolant temperature: 70 -100°C (158 - 212°F)
  - Battery voltage: More than 12.9V (at idle)
  - Transmission: Warmed up

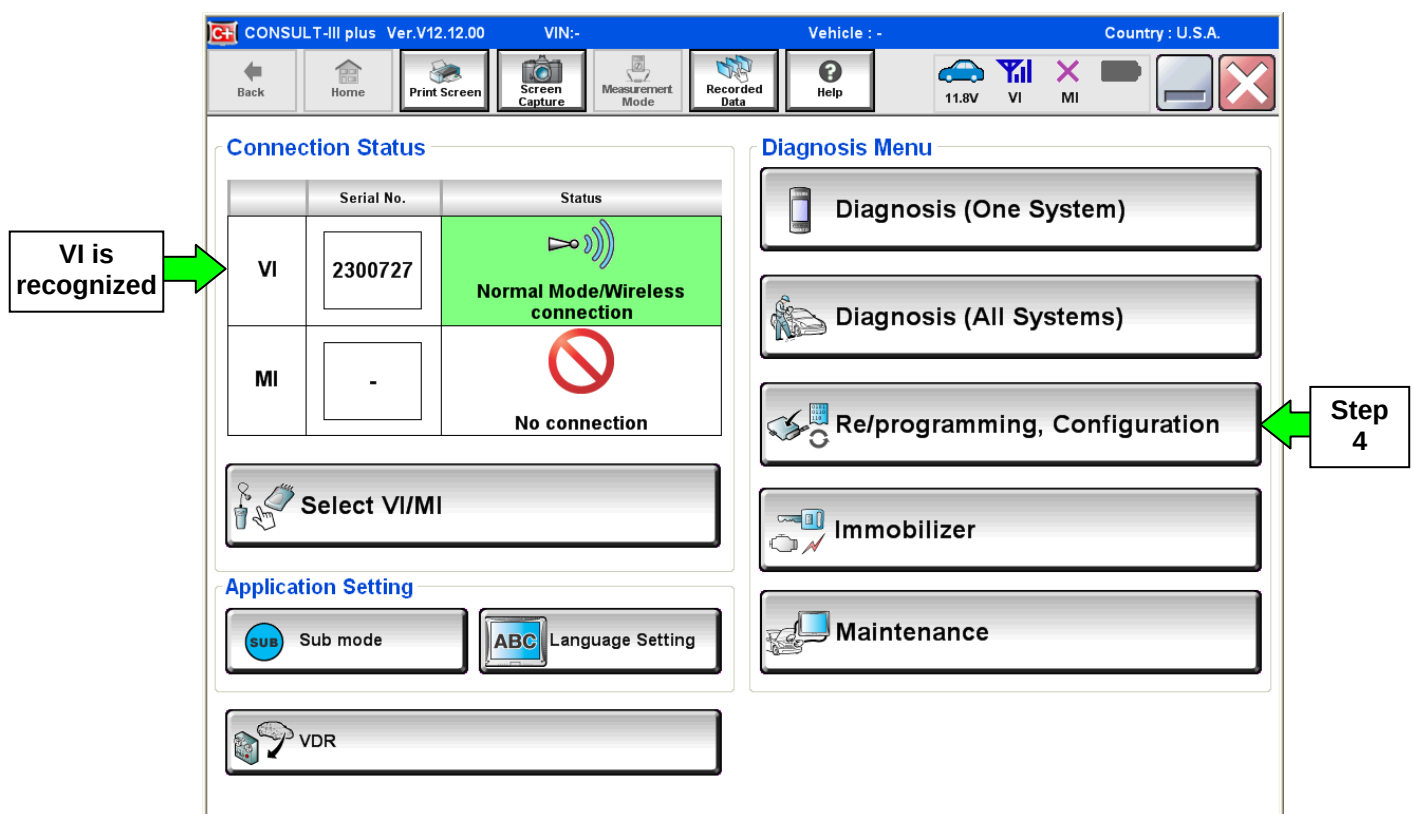
Figure 1

1. **Connect the CONSULT PC** to the vehicle to begin the reprogramming procedure.
2. Open ASIST on the CONSULT PC and start C-III plus.
3. Wait for the plus VI to be recognized / connected.
  - Serial number will display when the plus VI is recognized / connected.
4. Select **Re/programming, Configuration**.

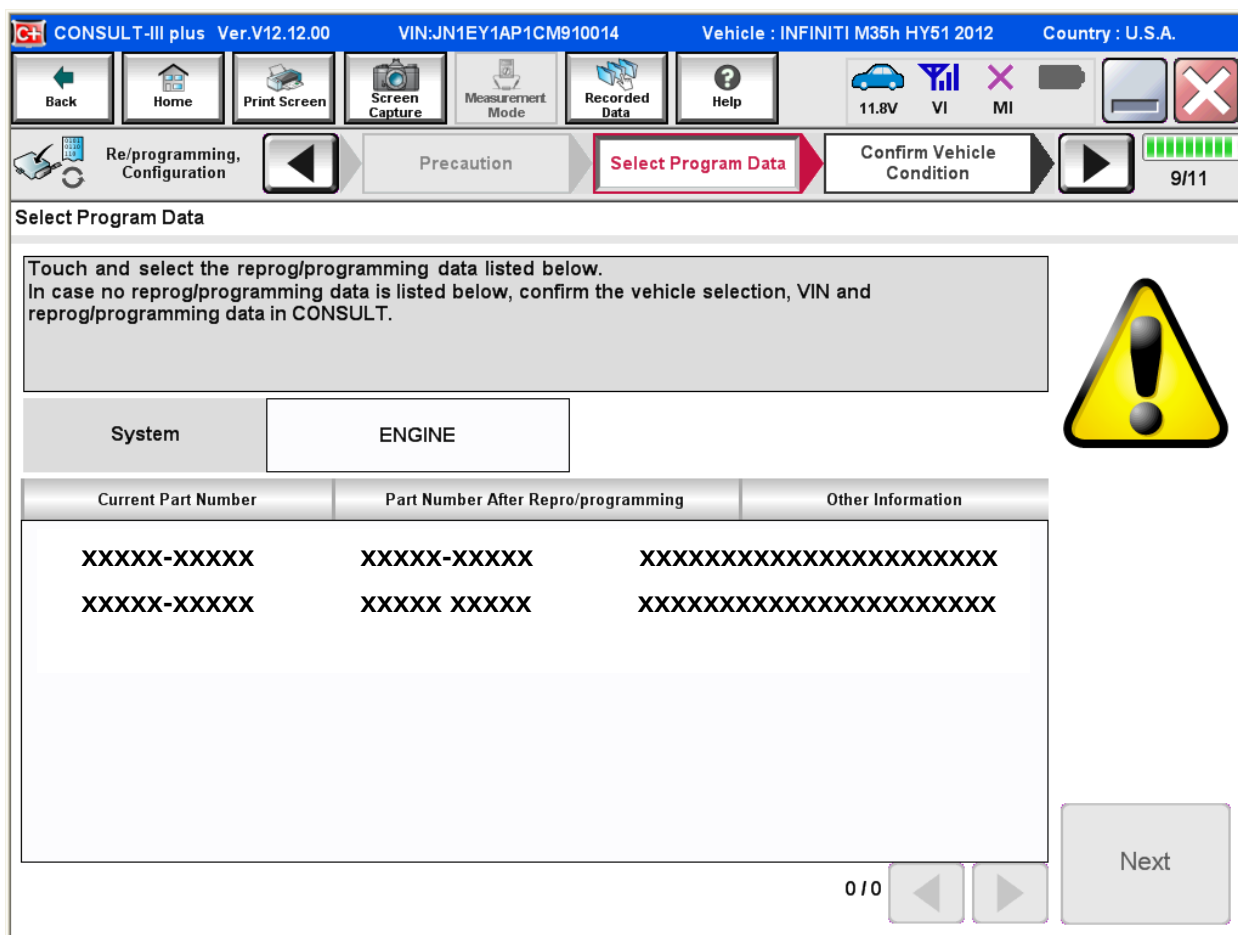
- In some cases, more than one new P/N for reprogramming is available.
  - In this case, the screen in Figure 3 displays.
- Select and use the reprogramming option that **does not** have the message “Caution! Use ONLY with NTBXX-XXX”.
- If you get this screen and it is **blank** (no reprogramming listed), it means there is no reprogramming available for this vehicle. Close C-III plus and refer back to ASIST for further diagnosis.

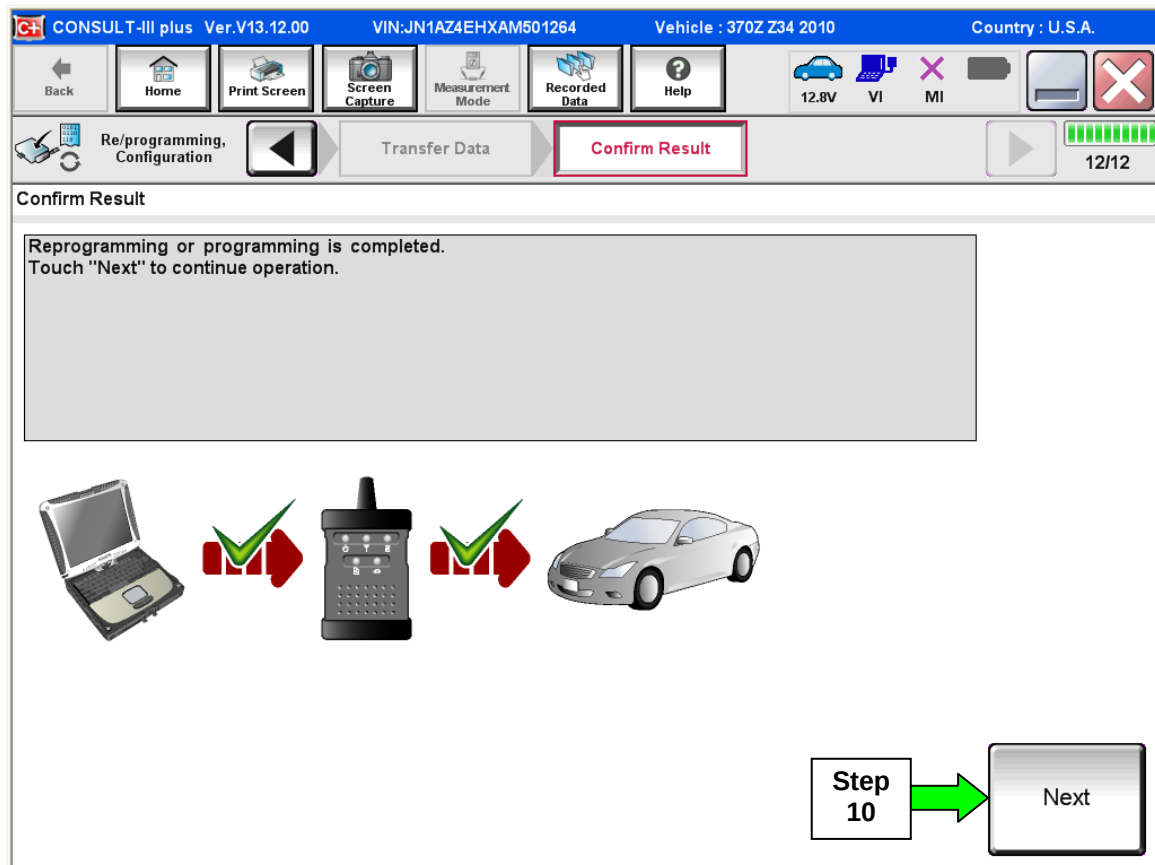
8. When the screen in Figure 4 displays, reprogramming is complete.
9. Disconnect the battery charger from the vehicle.
10. Select **Next**.

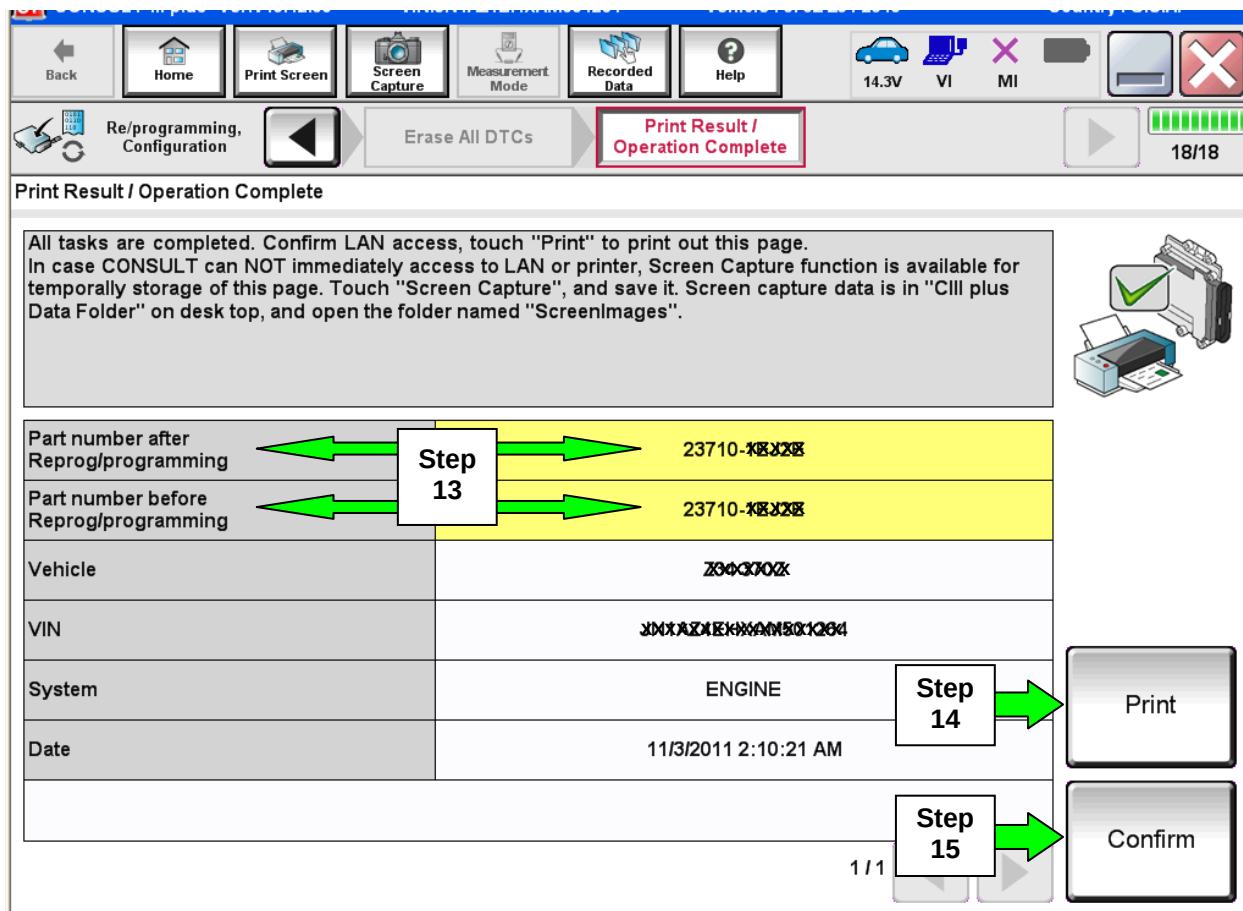
12. When the entire reprogramming process is complete, the screen in Figure 5 will display.
13. Verify the before and after part numbers are different.
14. Print a copy of this screen (Figure 5) and attach it to the repair order for warranty documentation.
15. Select **Confirm**.
